# Home Inspection Report

**123 Home Street, Winona, MN 55987**

Friday, March 11, 2016

# Report Summary

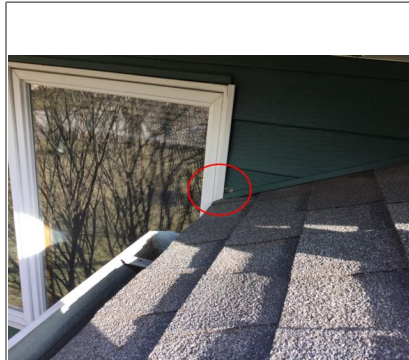
Observed missing kickout flashing

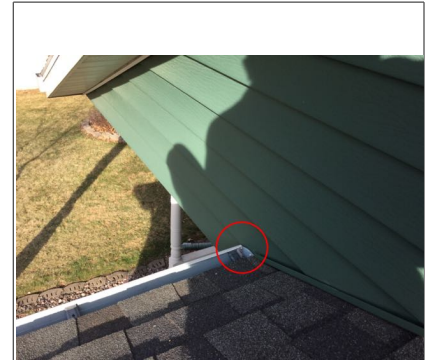
Observed missing kickout flashing

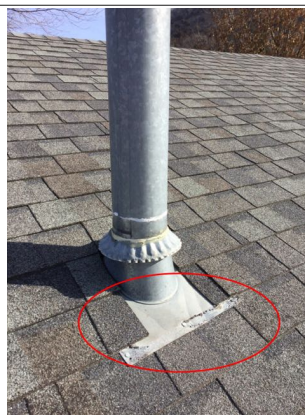
Recommend applying sealant on the nail heads. Possible point of moisture intrusion.

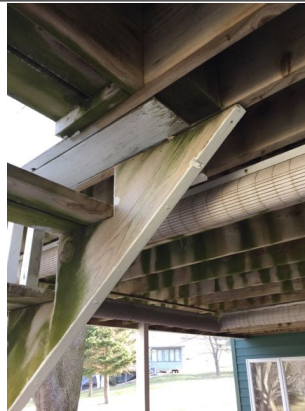
Observed improper stair stringer attachment to the deck.  
Recommend a qualified/licensed contractor review and repair/replace as needed.

Improper attachment of stair stringer to the deck. Recommend a contractor/licensed professional review and repair/replace as needed (Location - rear deck above the hot tub)

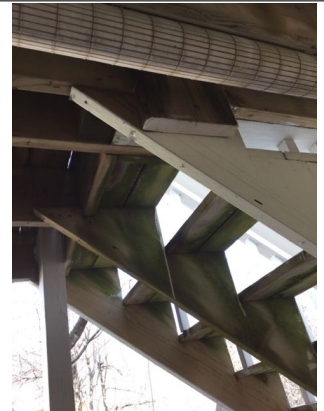
Observed improper stair stringer attachment to the deck.  
Recommend a qualified/licensed contractor review and repair/replace as needed.

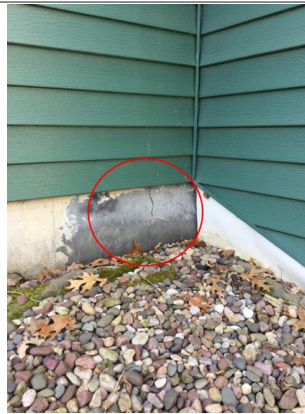
Observed vertical crack in foundation wall. Recommend asking the seller when this happened and if any repair work has been performed on it in the past. Recommend reviewing the disclosures as well.

Recommend to monitor the crack in the foundation wall for future movement.

Recommend asking the seller for more information regarding the repair work done to the crack in the foundation.

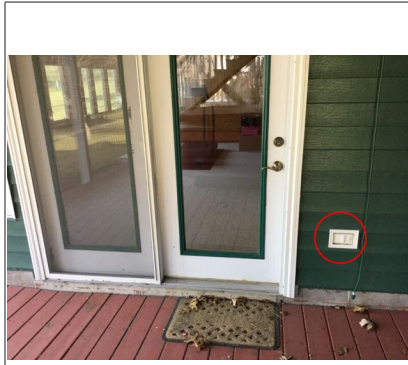
Observed GFCI receptacle that did not respond to Test and Reset features. Recommend a licensed electrician review and repair/replace as necessary. (Location - in the vicinity of the hot tub)

Observed GFCI receptacle that did not respond to Test and Reset features. Recommend a licensed electrician review and repair/replace as necessary. (Location - in the vicinity of the hot tub)

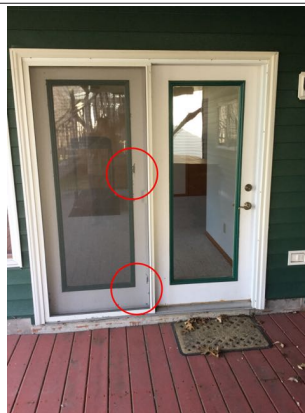
Location: Exterior door close to hot tub

Observed paint chipping/peeling of exterior door.

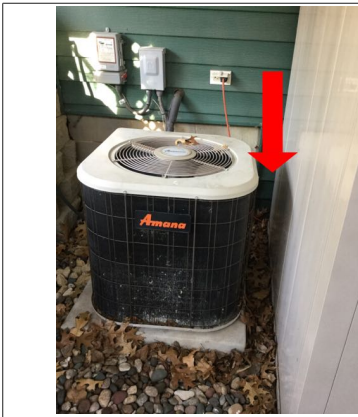
Observed possible improper clearance of unit to other objects. Improper clearance can lead to poor air flow.

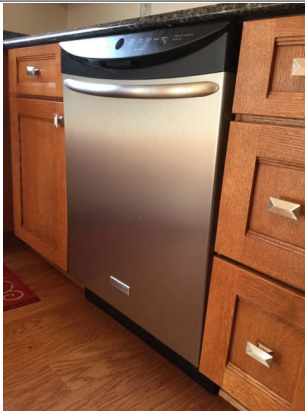
Dishwasher leaks beneath unit. Recommend repair

Observed water leaking out of the dishwasher when a cycle was ran.

Dishwasher leaks beneath unit. Recommend repair

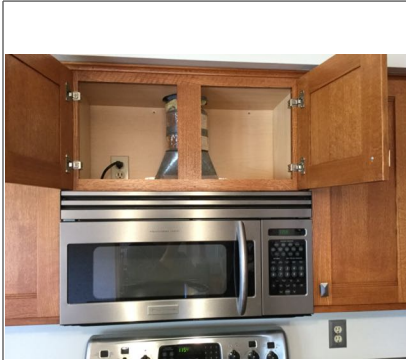
Observation: The kitchen vent appears to be ducted to the exterior. When the fan was turned on, the air leaked around the top of the microwave as well as the connection in the duct vent. Recommend professional contractor review and repair/replace as necessary.

Observation: The kitchen vent appears to be ducted to the exterior. When the fan was turned on, the air leaked around the top of the microwave as well as the connection in the duct vent. Recommend professional contractor review and repair/replace as necessary.

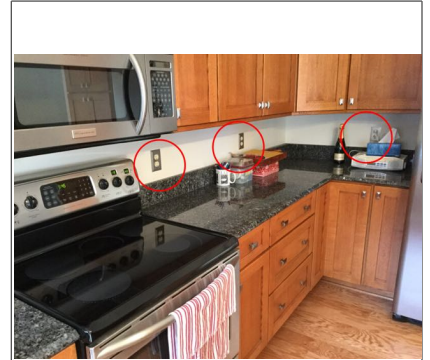
Recommend GFCI receptacles for all receptacles above countertop. The marked receptacles were not GFCI protected.

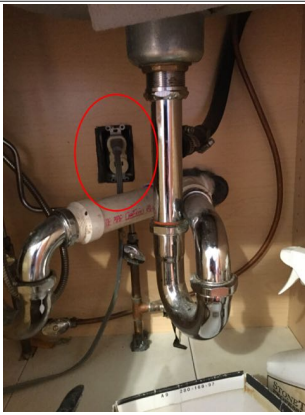
Observed missing cover plate from receptacle. Observed loose receptacle. Recommend a licensed electrician review and repair/replace as needed.

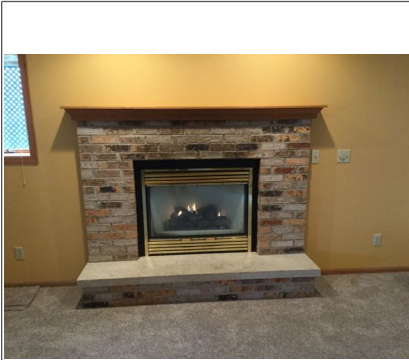
Fireplace was operable. Observed noisy fan motor when speed was turned to high. Recommend unit be cleaned as needed to prolong life expectancy of components.

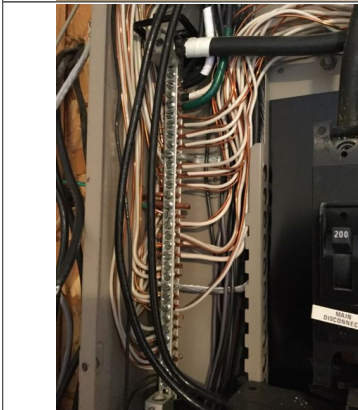
Observed ground and neutral conductor sharing the same lug. Neutral and ground conductors should not share the same lug.

Recommend consulting with a licensed electrician regarding proper grounding techniques.

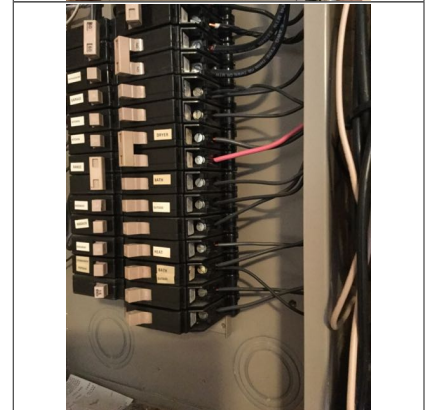
Observed multiple conductors sharing the same lug. Conductors should not share the same lug.

Recommend consulting with a licensed electrician regarding double tapping of conductors.

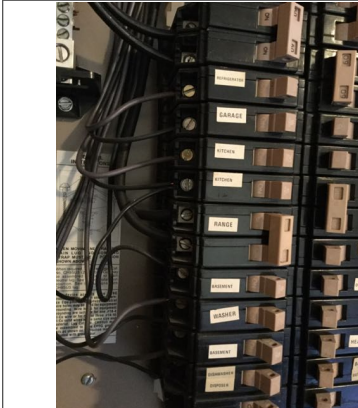
Observed multiple conductors sharing the same lug. Conductors should not share the same lug.

Recommend consulting with a licensed electrician regarding double tapping of conductors.

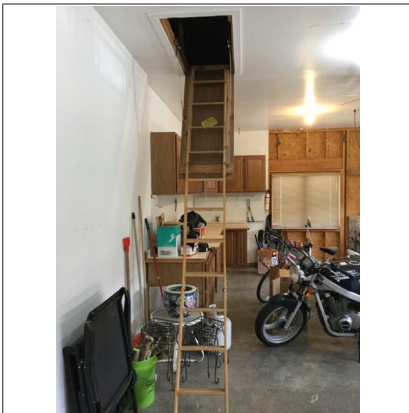
Observed unstable attic access ladder. Recommend upgrading access ladder for safety reasons.
