# *Property Condition Report*

High Point Shopping Center  
1234 Main Street  
Rochester, MN 55901

**Inspection Date:** 02/12/2016

Integri-Spec LLC  
479 Mankato Ave Suite 204  
Winona, MN 55987  
507-458-4566

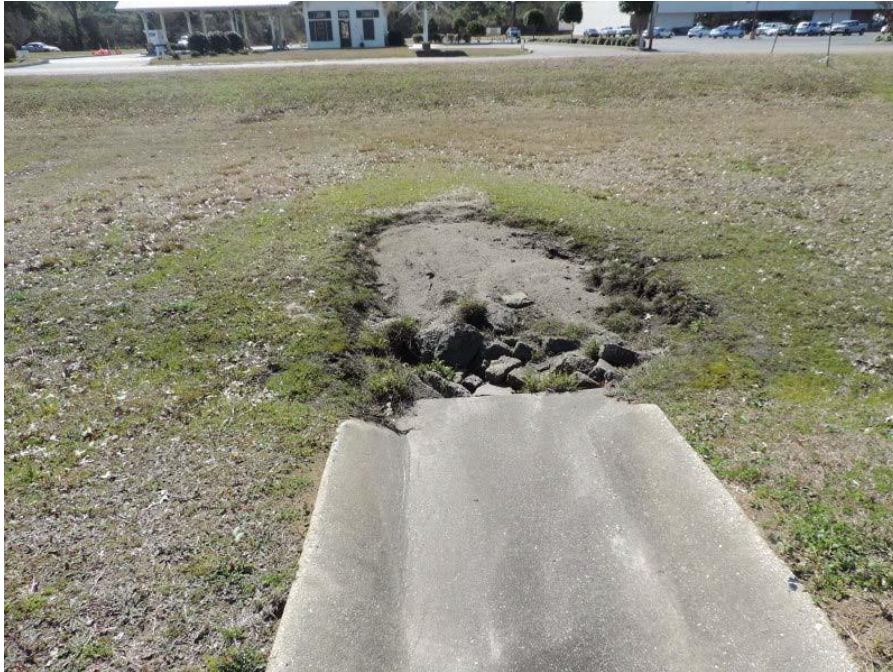
Area of soil erosion at concrete raceway to detention pond

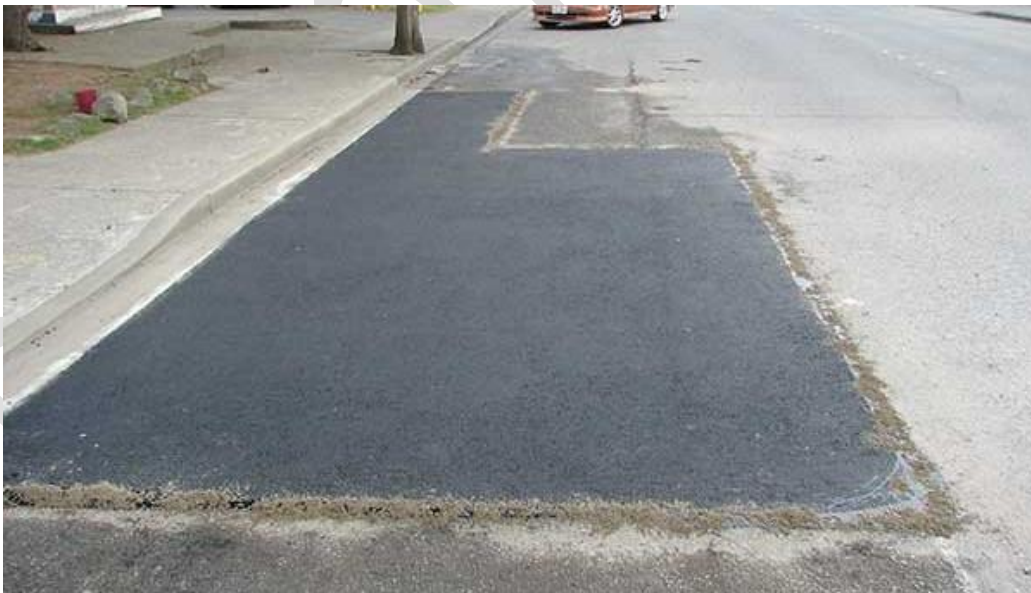
Recently patched pavement

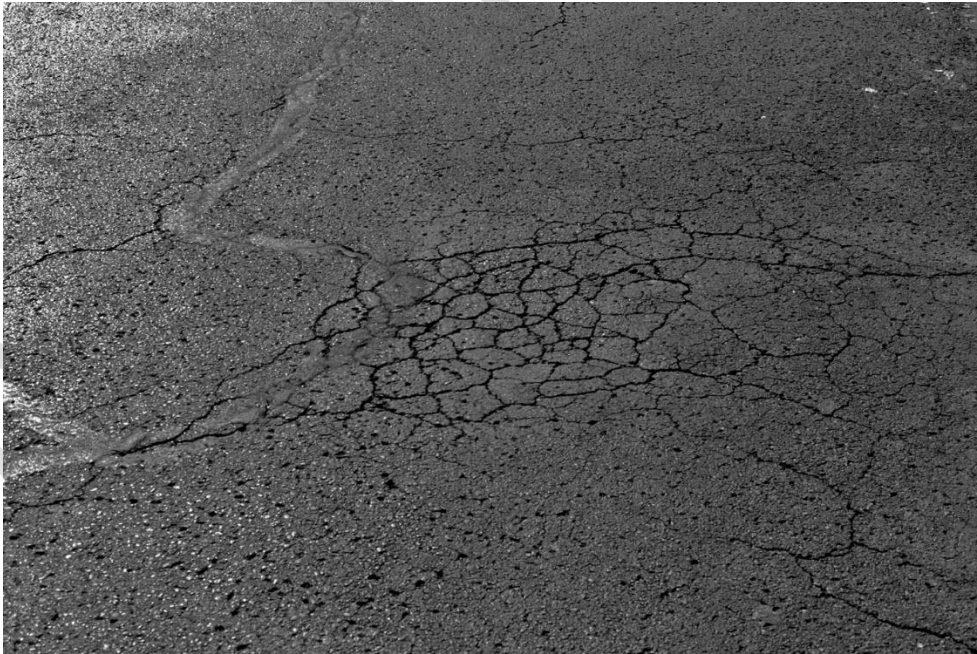
While the majority of the main parking lot and driveways have been sealed recently, it appears that many areas with pavement damage, such as alligator cracking, were sealed over, rather than repaired. Alligator cracking and raveling was observed in many locations. Additionally, the rear (north) service drive exhibits significant cracking and raveling. The damaged/deteriorated asphalt pavement should be repaired/replaced, in order to prevent further deterioration. Minor cracks can be crack filled, some areas can be patched/ overlain and the more significantly deteriorated areas should be removed and repaved. An opinion of costs for this work has been included in the Short Term Costs Table.

Typical alligator cracking

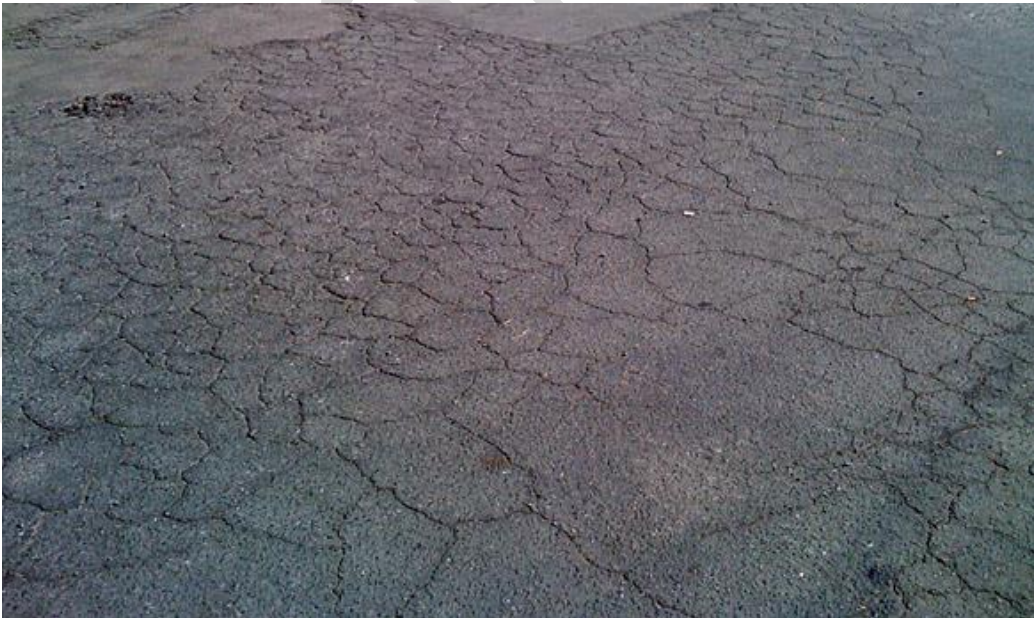
Typical alligator cracking and raveling

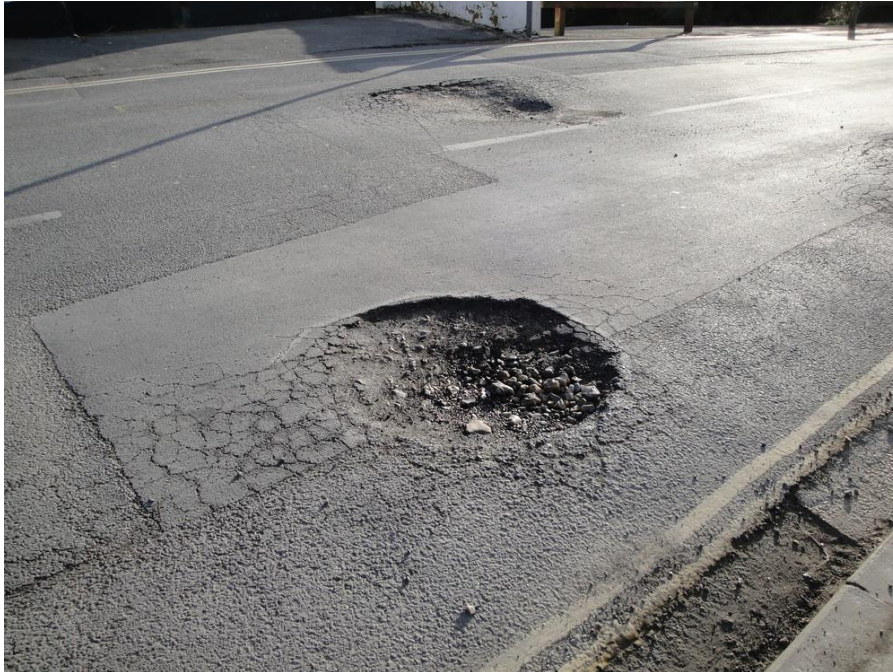
Typical pavement damage

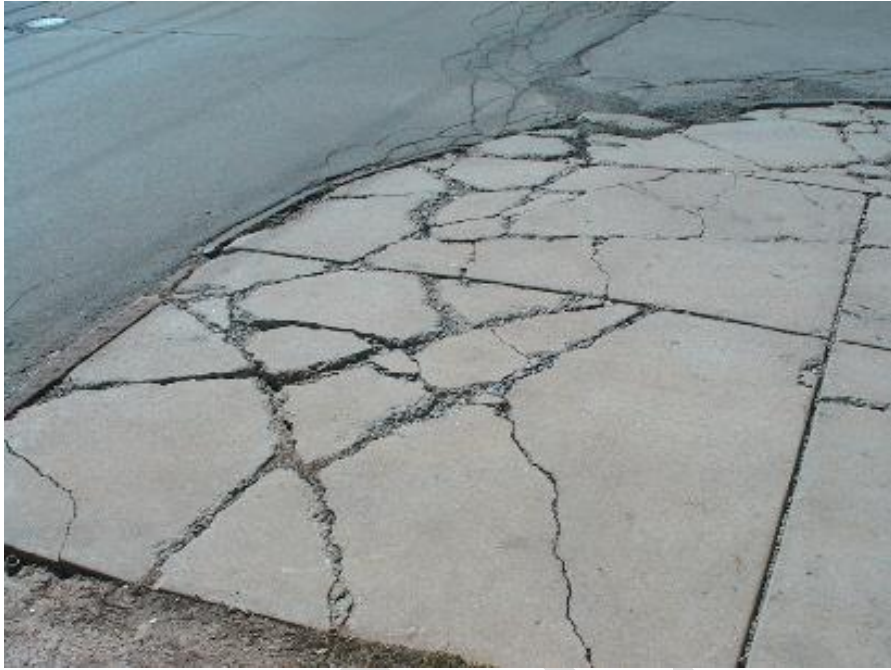
Typical cracking in sidewalk

Concrete flatwork generally has a EUL in excess of 25 years if constructed over a properly stabilized base and maintained regularly. Integri-Spec has included costs for ongoing concrete repairs in the Replacement Reserve Schedule.

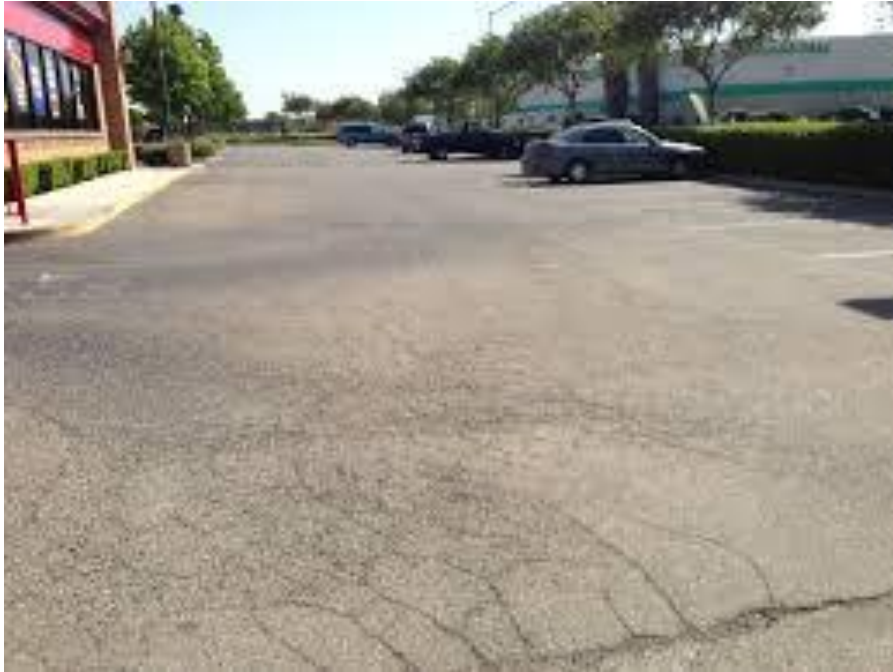
Driveway; note cracking

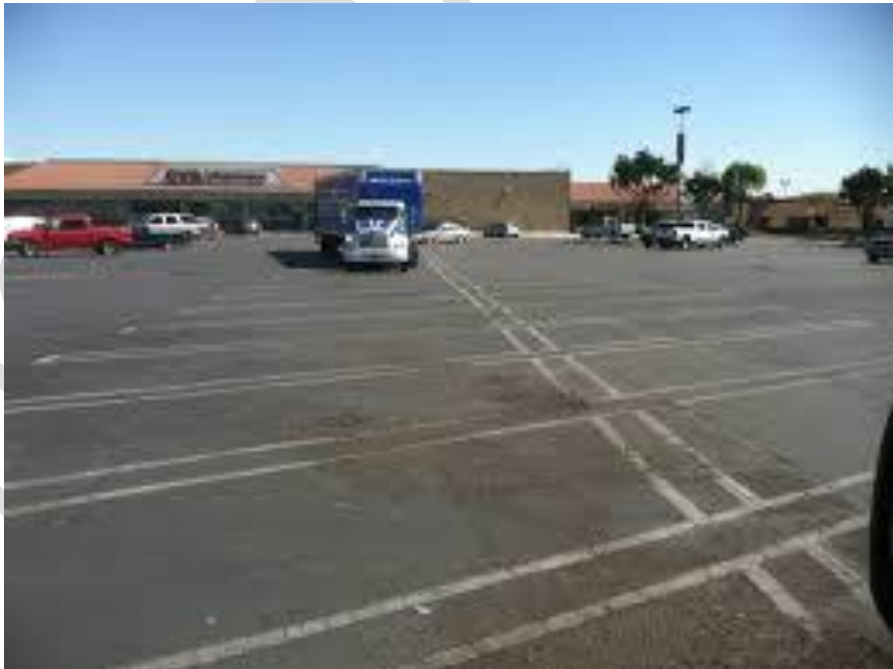
Typical alligator cracking and other pavement damage

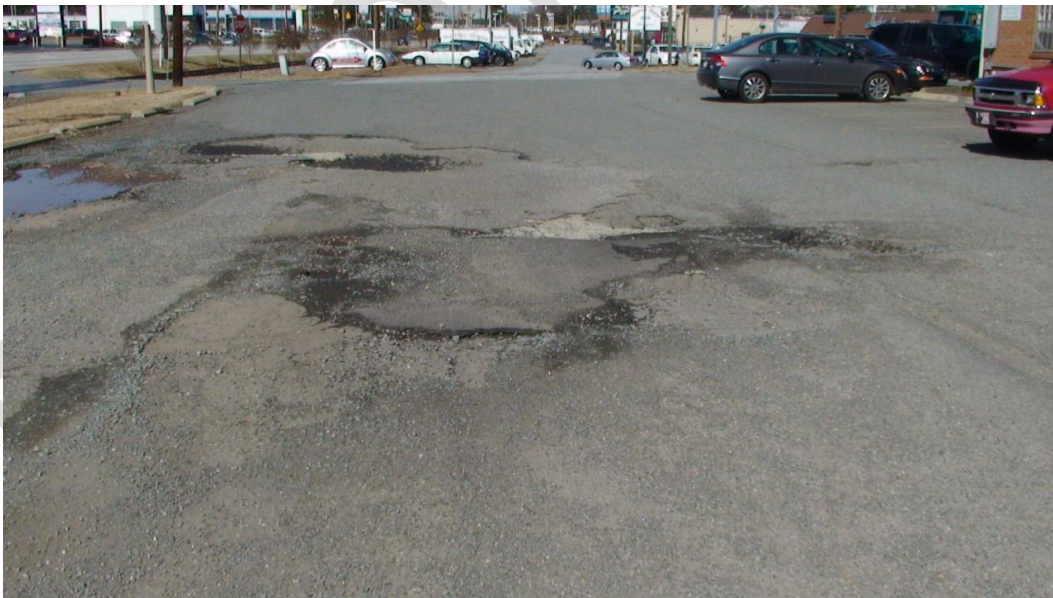
Pavement damage in northern service drive

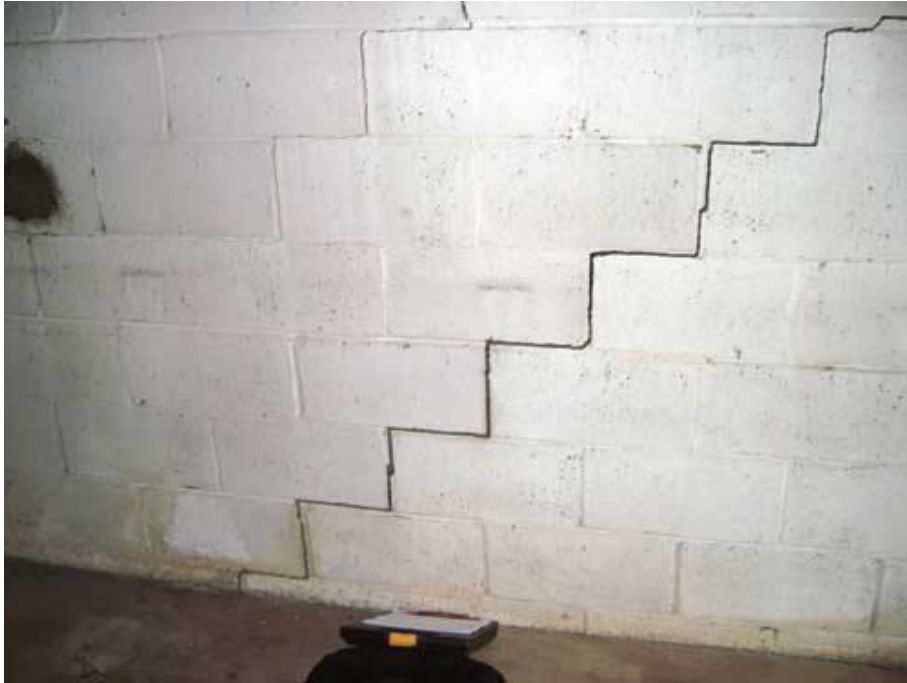
Cracking of the CMU walls throughout the rear building areas was observed, some of which is significant. Some of the cracking appears to have led to interior water intrusion issues.

Cracking of exterior wall

**Recommendations:** CMU walls showing damage on both the interior and exterior should be repaired, cleaned and maintained, and testing should be completed to positively determine the reason for the observed water intrusion. An opinion of costs for this work has been included in the Short Term Costs Table.

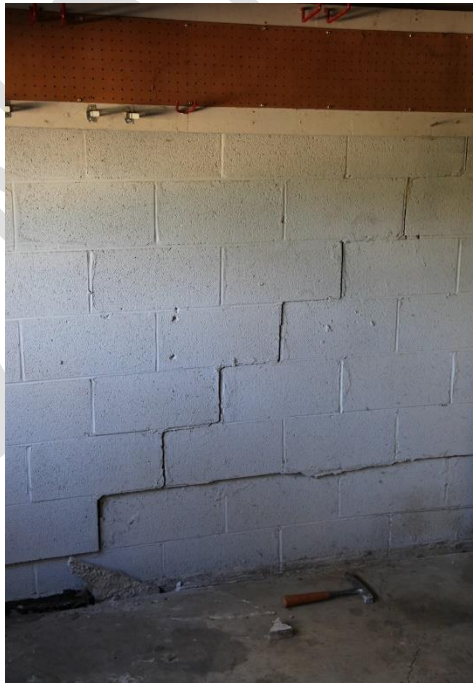
Cracking of exterior wall

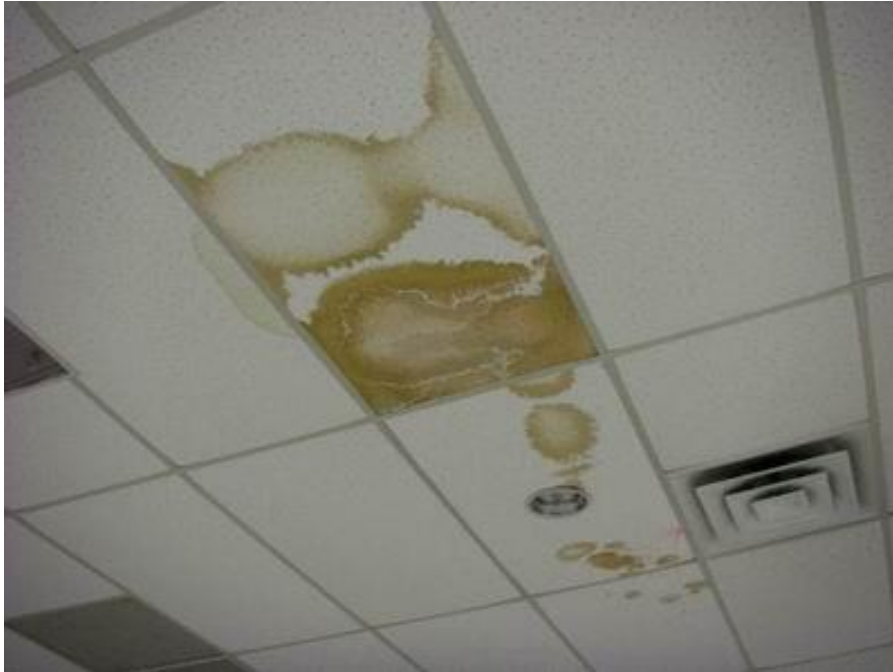
Evidence of water intrusion

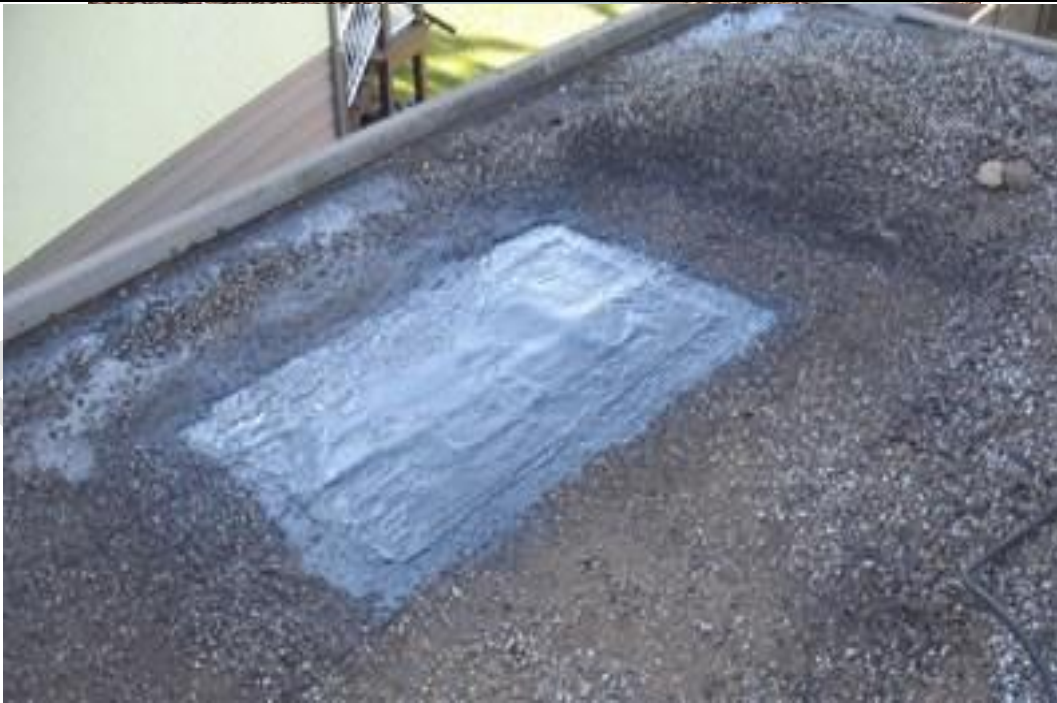
Based on the age of the roof, reported significant roof leaks, and a EUL of 20 years for flat roofs, replacement will likely be required at the beginning of the term. An opinion of costs for this work is included in the Short Term Costs Table.

Roof repair

Recommendations	Overall Condition	Budget Cost (2016 Dollars)	Timeframe
Roof replacement	Fair	25,000 sq ft @ \$6/sqft = \$150,000 - \$200,000	Immediate

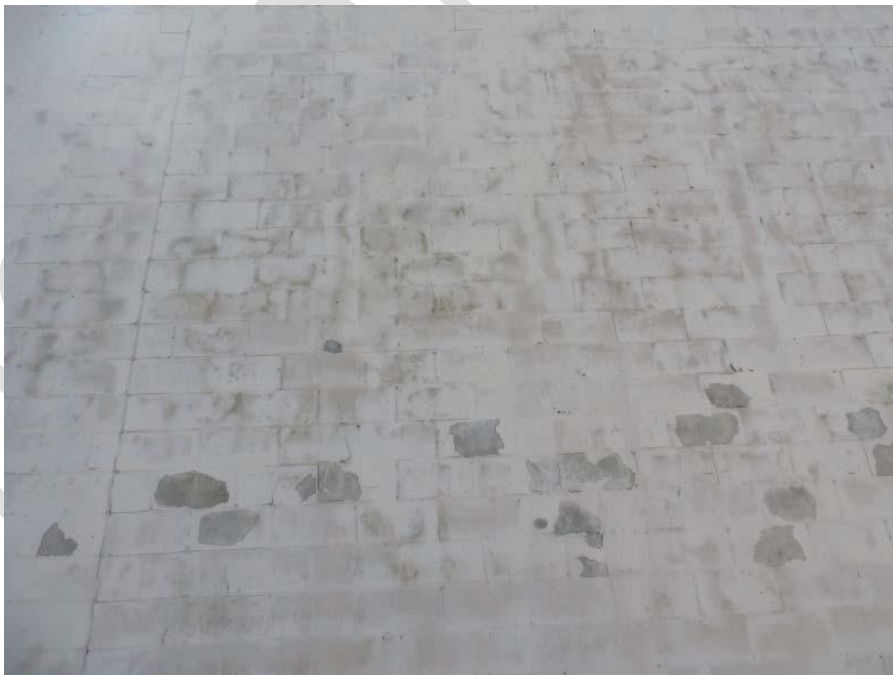
Deteriorated paint

Any deteriorated caulking/pointing should be replaced. Exterior maintenance such as painting, power washing, caulking, stucco patching, etc., is typically required every six to eight years depending on the quality of preparation of the surfaces, the quality of materials used and weather conditions. The building currently requires this exterior maintenance. An opinion of costs for the above work is included in the Short Term Costs Table.

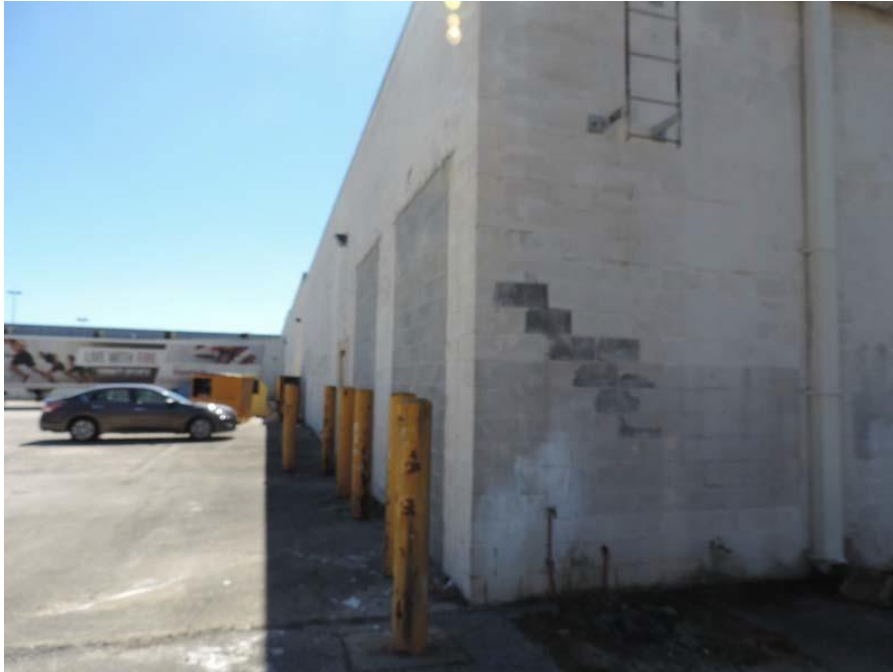
Deteriorated paint

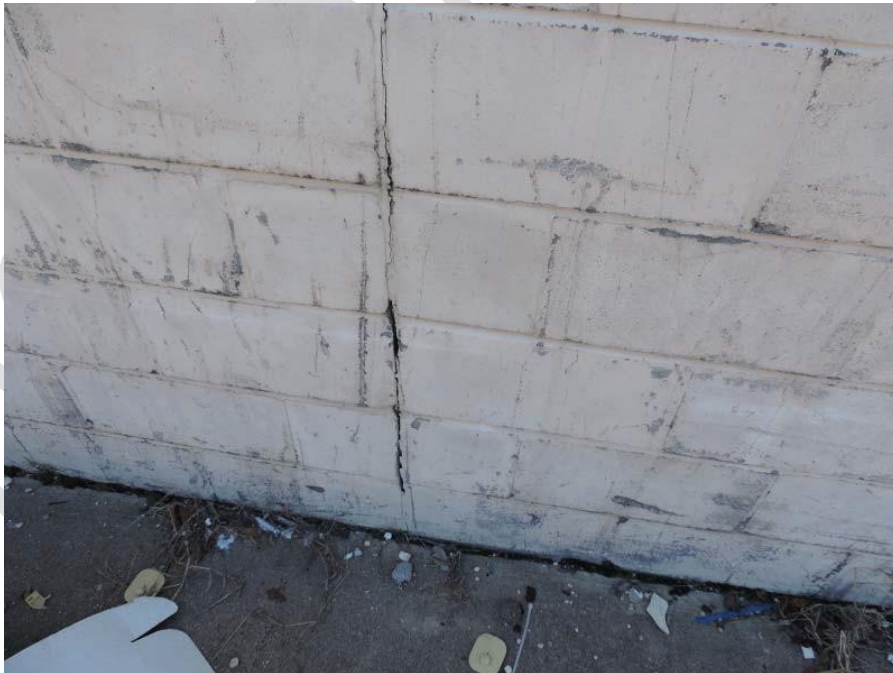
Deteriorated caulking/pointing

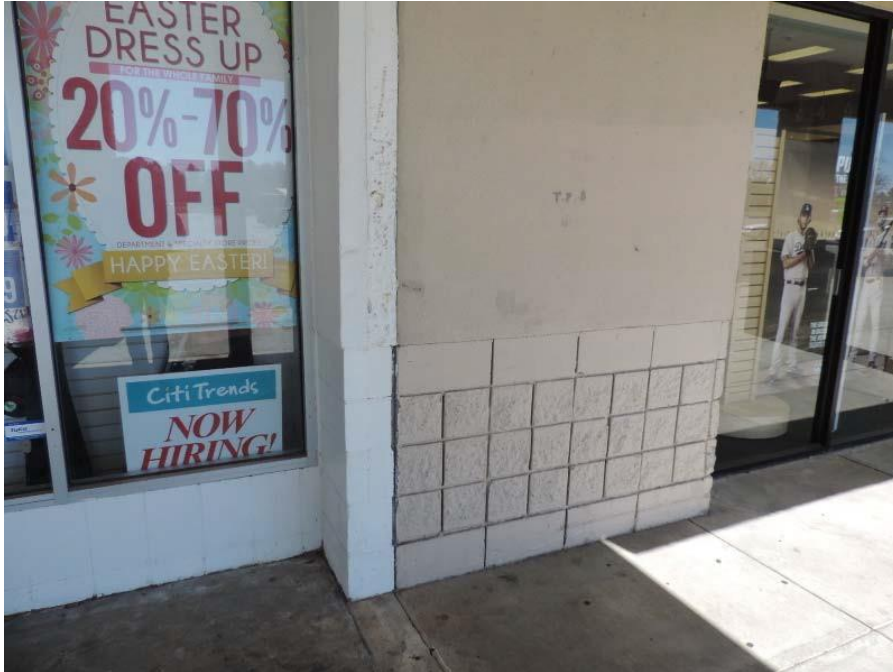
Damaged EIFS (minor)

Minor EIFS damaged can be patched as part of routine maintenance. The remaining portions of the facade should be monitored and addressed as part of the routine maintenance of the property.

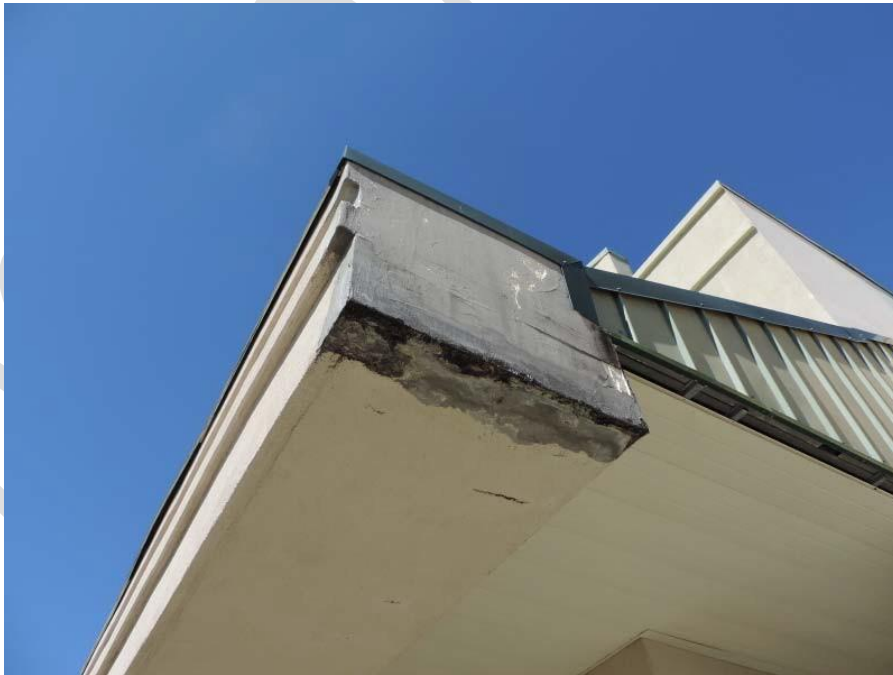
Recent EIFS repair

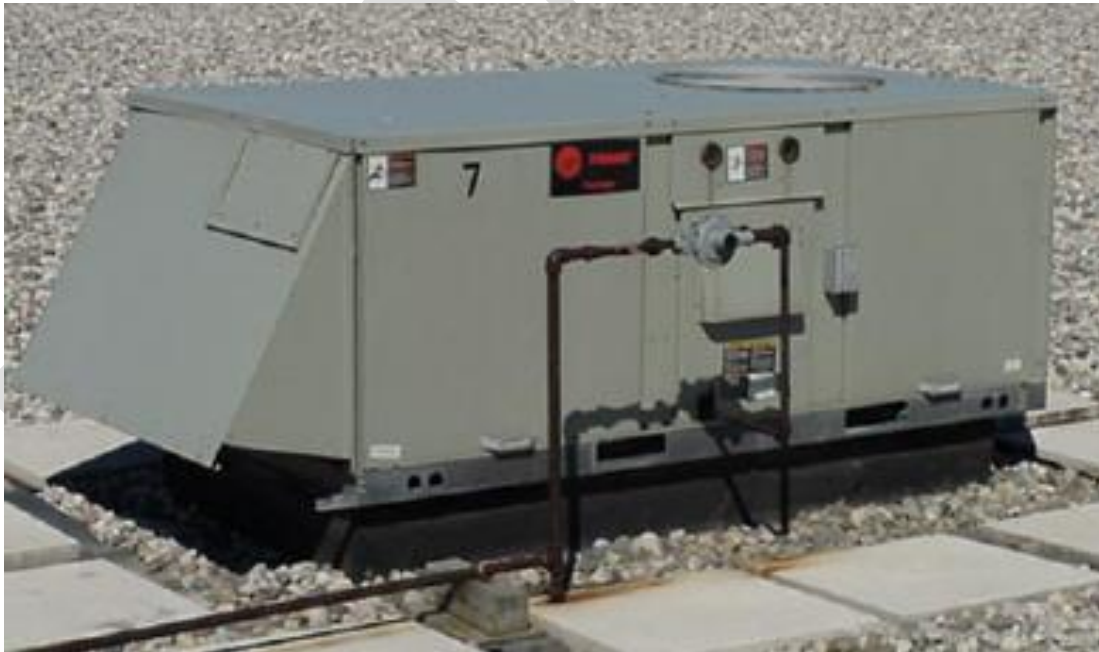
Inoperable unit

The five inoperable HVAC units should be removed from the roof to prevent any water intrusion issues. The curbs should then be covered. This can be handled as part of routine maintenance. As the property owner is responsible for providing a working system at tenant turnover, the replacement of the units at the vacant tenant space (approximately 30 tons) will likely be necessary. Costs for the replacements are included in the Short Term Needs Table. Otherwise, given a EUL of 20 years for the packaged units, it is not anticipated that any of the other HVAC equipment will require replacement during the term.

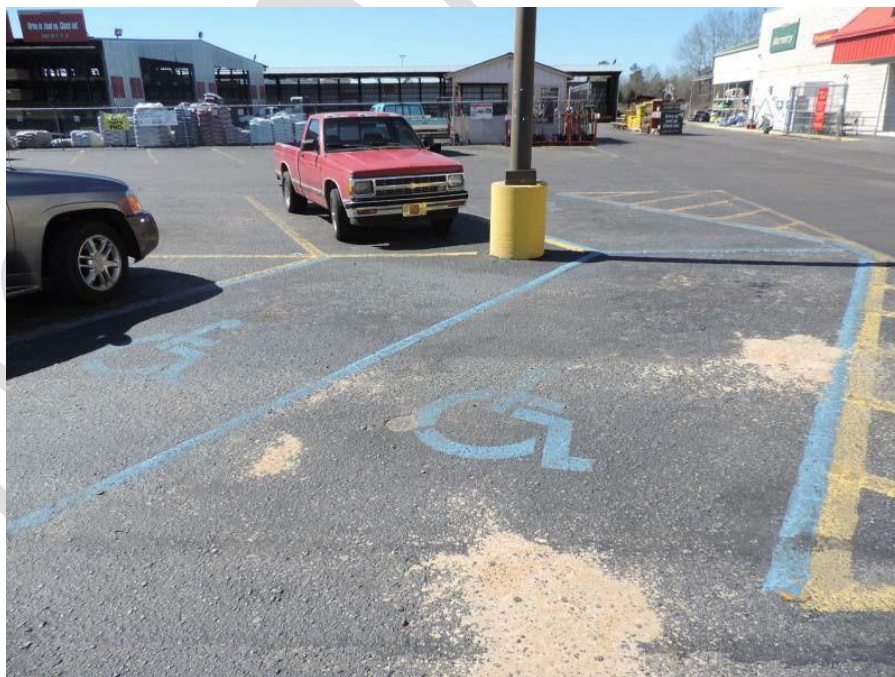
Three of the ADA parking spaces were observed to lack vertical signage. As such, vertical signage should be installed at these spaces. Costs for this work are included in the Short Term Costs table.

ADA parking spaces missing vertical signage

Recommendations	Overall Condition	Budget Cost (2016 Dollars)	Timeframe
Install vertical signage at three ADA spaces	Missing / Not Present	3 units @ ~\$500/unit = \$1,500	Immediate

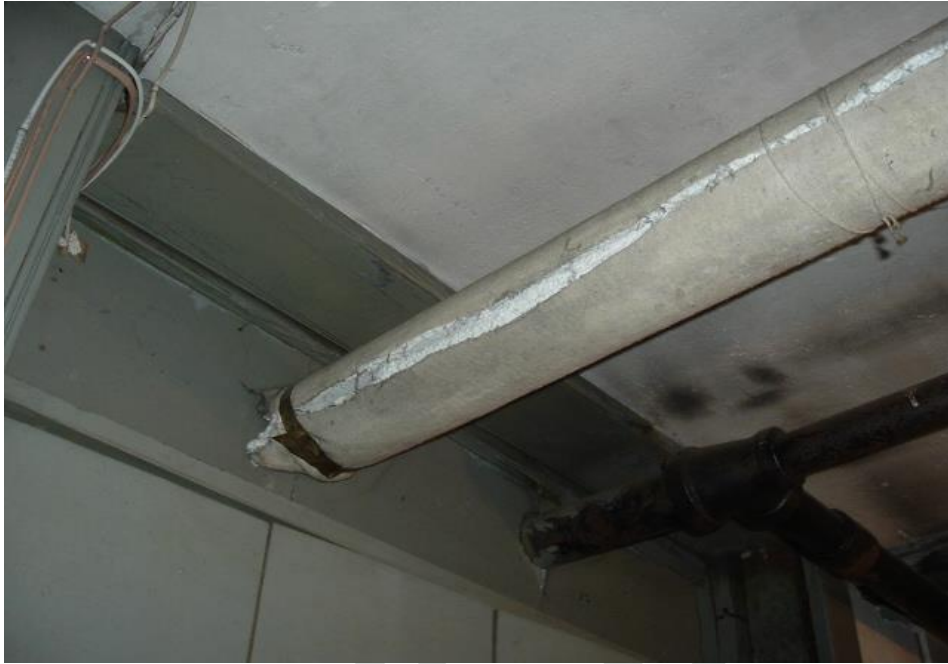
A comprehensive mold survey was beyond the scope of this assessment; however, during the assessment, visual evidence of active water and mold damage was observed throughout the interior areas inspected by Integri-Spec. In particular, mold growth appeared to be associated with water damage from multiple roof leaks. Mold growth was observed on water piping in the Mackenzie's space, and according to a Mackenzie's store employee, mold grows through the floor tiles and must be cleaned every once in a while.

### Mold growth

**Recommendations:** It is recommended that mold-impacted building materials are removed and replaced in accordance with EPA guidelines. Additionally, due to the history and continued presence of water intrusion issues at the subject property, a Moisture Minimization Plan should be implemented at the subject property. The plan takes a proactive, preventative approach in order to minimize any moisture damage and/or mold impact by insuring the early identification and repair of potential problems. Integri-Spec has included costs for this work in the Short Term Costs Table. As previously mentioned, water damaged ceiling tiles can be removed and replaced as part of routine maintenance.

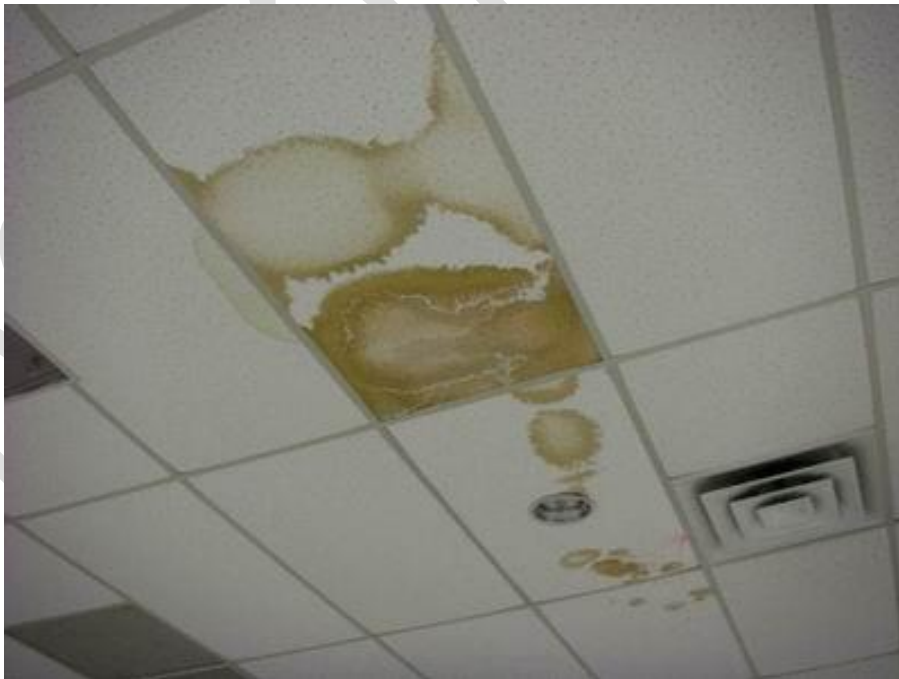
### Water damaged ceiling tiles with mold growth
