Home Inspection Report

51234 Main Street, Winona, MN 55987

Sunday, January 1, 2017

Integri-Spec Home Inspections

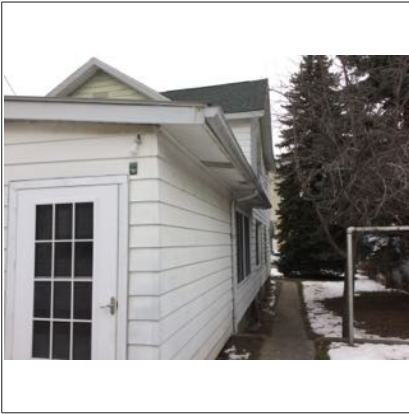
Gutters on only a portion of the house, recommend additional gutters where needed.

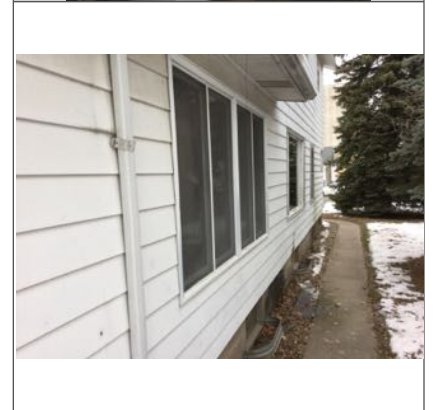
Observed loose siding.

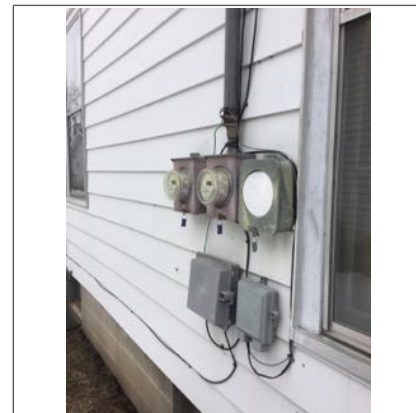
Observed exterior light Not installed correctly. Recommend licensed electrician review and repair as necessary.

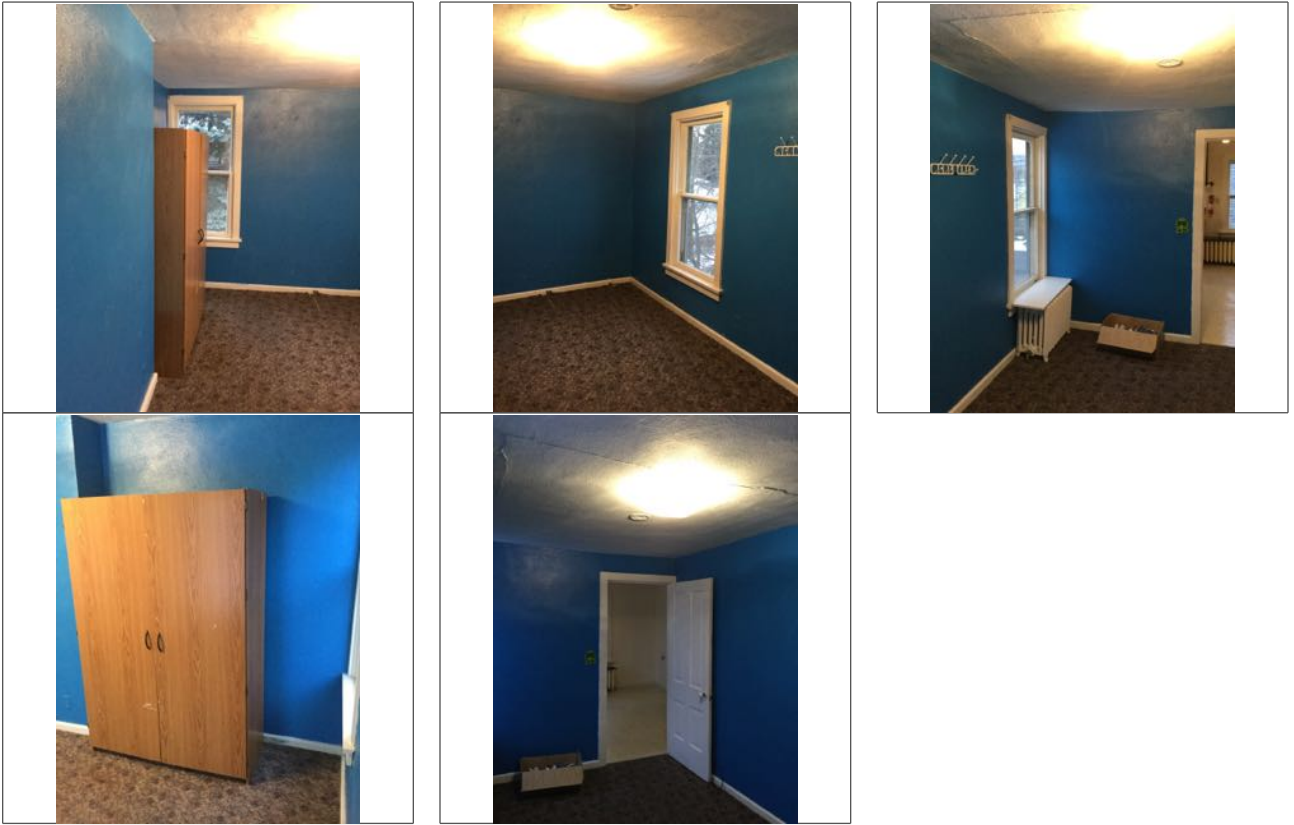
Comments Observed sloping floor.

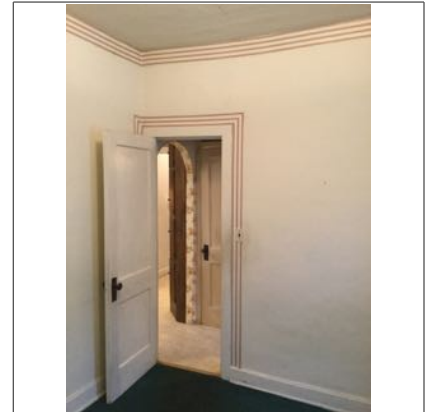
Observed loose light.

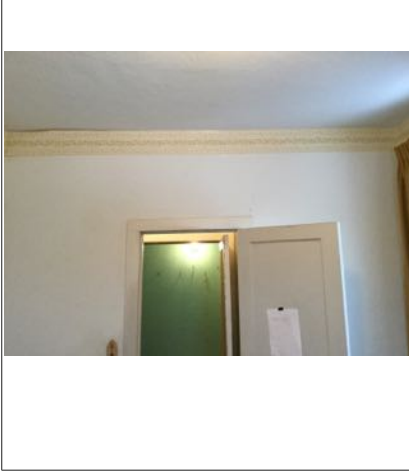
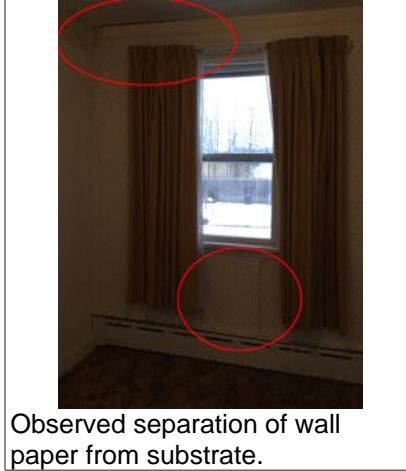
Observed separation of wall paper from substrate.

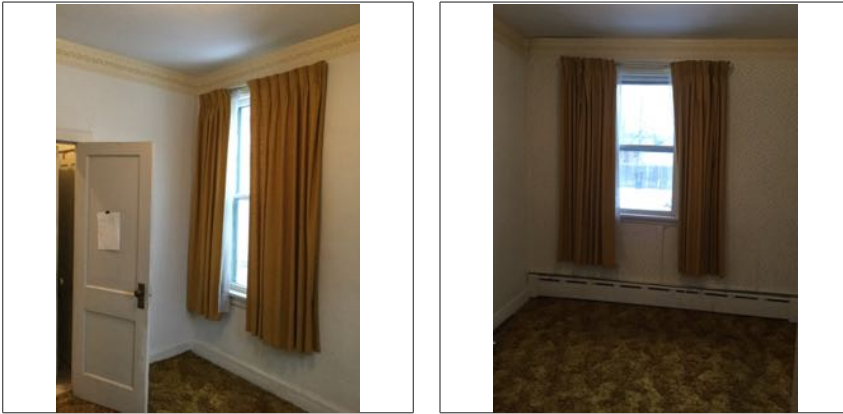
Comments Observed sloping and uneven floor.

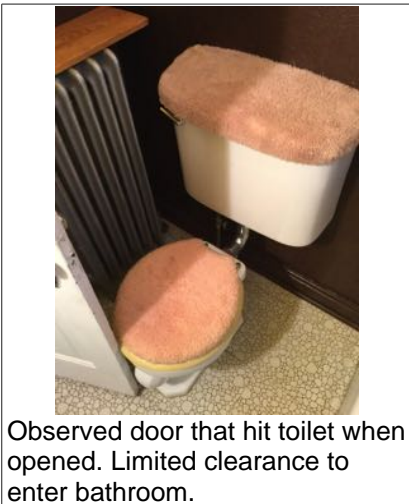
Observed door that hit toilet when opened. Limited clearance to enter bathroom.

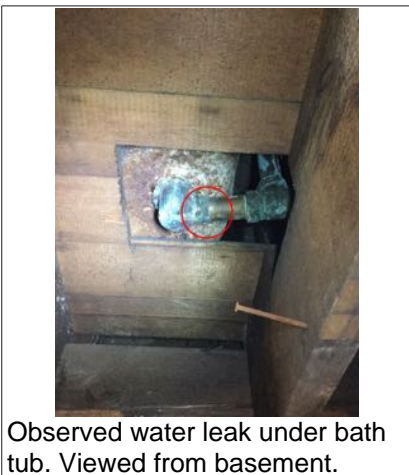
- ~Observed water leak near boiler. Recommend licensed professional review and repair as needed to ensure leak is eliminated. Basement near boiler.
- ~Observed water leak under bath tub. Viewed from basement. Appears to be bathroom 3

Observed water leak under bath tub. Viewed from basement.

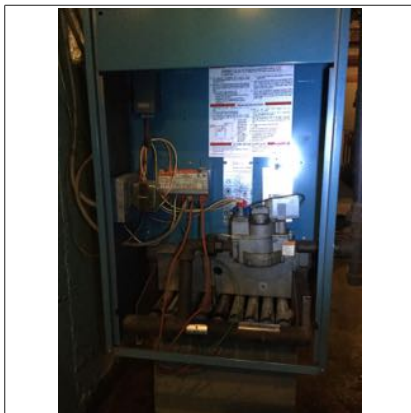
Observed water leak near boiler.
Recommend licensed
professional review and repair as
needed to ensure leak is
eliminated.
