# Home Inspection Report

**123 Home Street, Winona, MN 55987**

Friday, March 11, 2016

# Report Summary

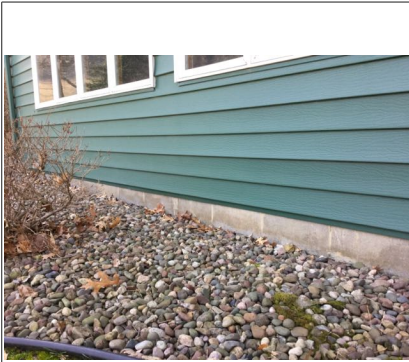
Observed vertical crack in foundation wall. Recommend asking the seller when this happened and if any repair work has been performed on it in the past. Recommend reviewing the disclosures as well.

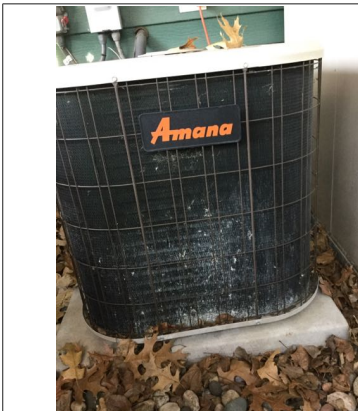
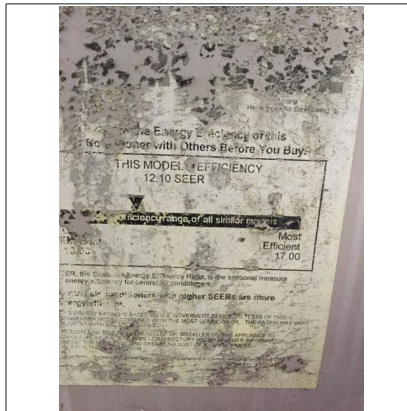
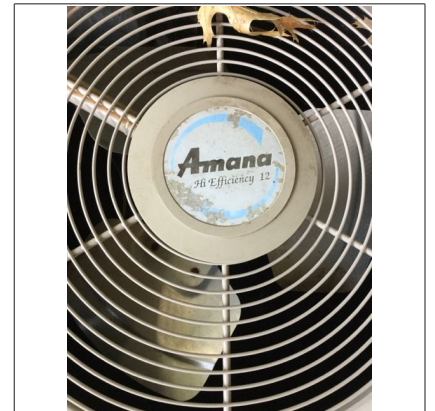
Observed possible improper clearance of unit to other objects. Improper clearance can lead to poor air flow.

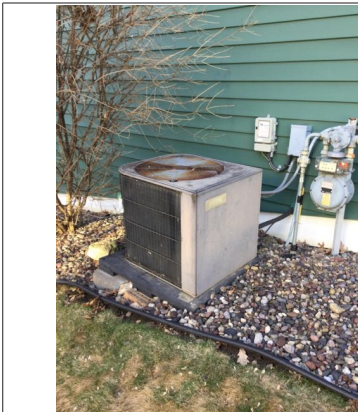
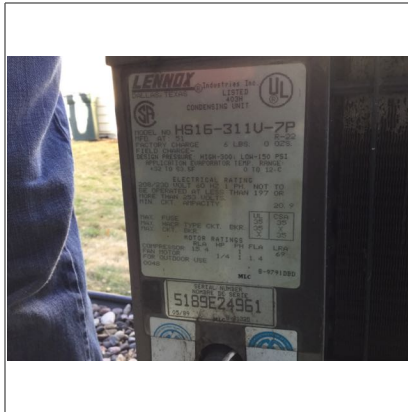
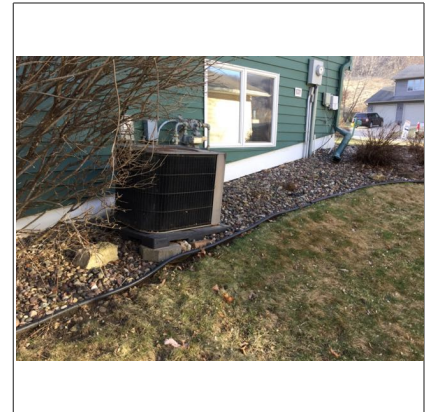
**Level** ☐ Yes ☒ No ☒ Recommend re-level unit

**Condenser Fins** ☐ Damaged ☒ Need cleaning ☐ Damaged base/pad ☐ Damaged Refrigerant Line ☐ Satisfactory

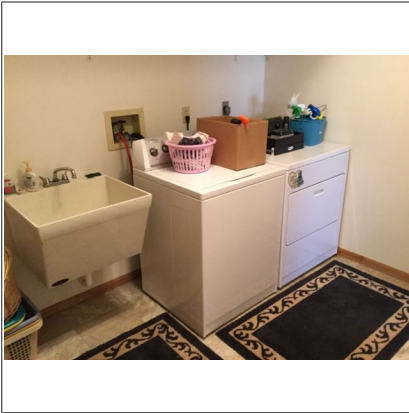
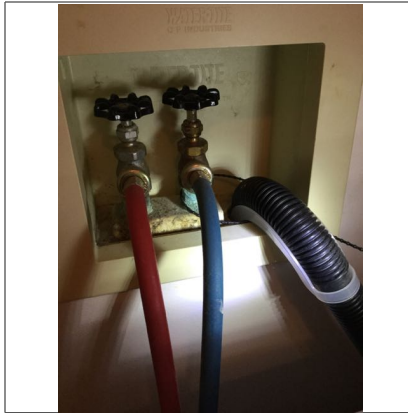
**Comments** Observed flexible transition dryer vent duct. Recommend limiting the length of flexible duct used and if possible using solid smooth metal duct instead of flexible.

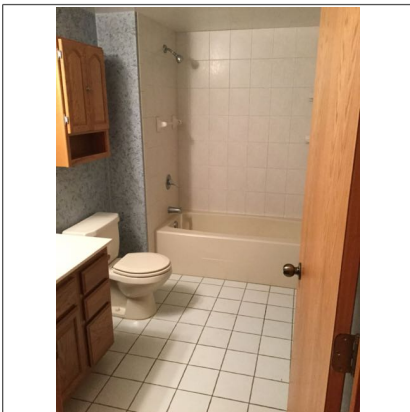
**Comments** Bathroom Exhaust fan operated but was noisy. Observed minimal air flow. Recommend a contractor/licensed professional review and repair/replace as needed.

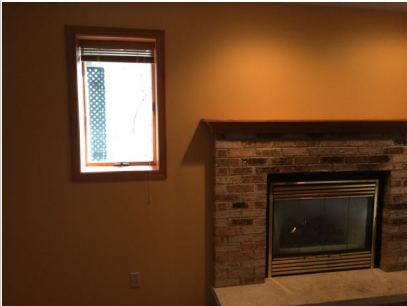
Sticky window

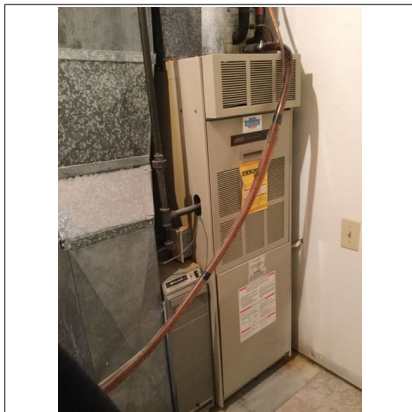
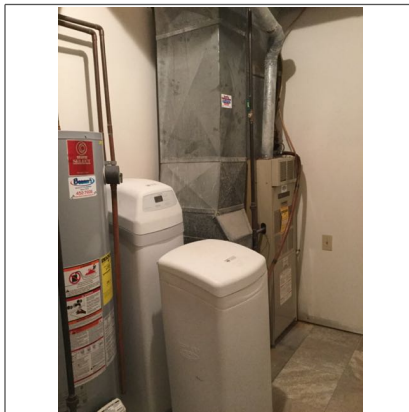
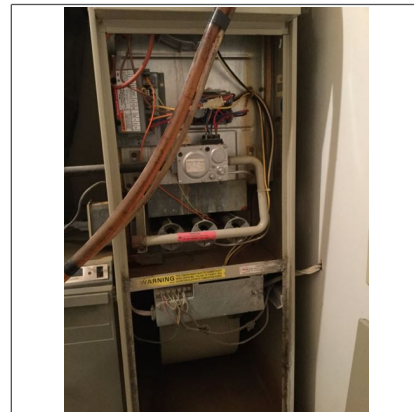
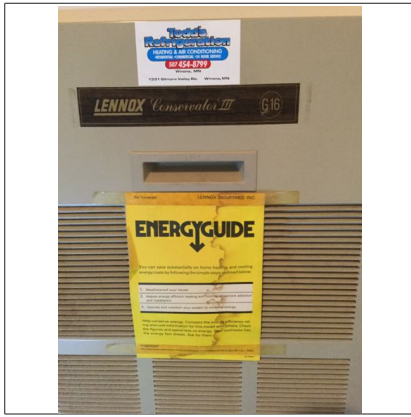
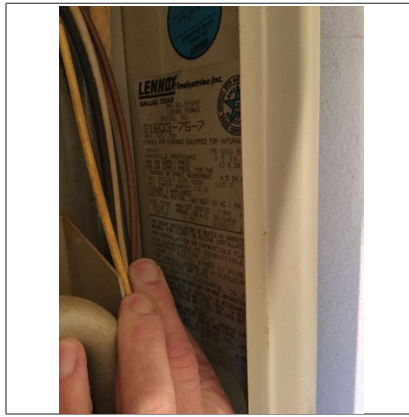
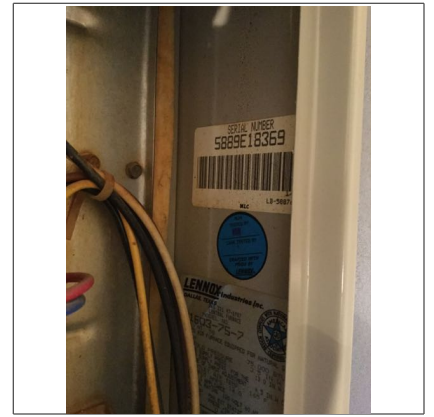
Furnace was marginal and aging, unit was nearing end of its useful life.

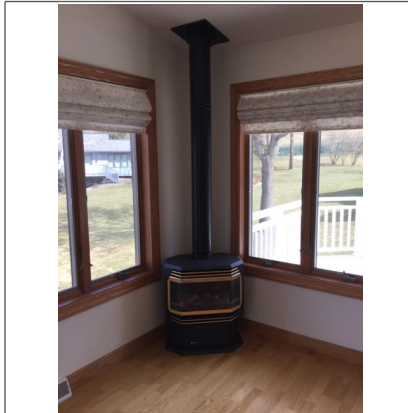
Fireplace was operable. Observed noisy fan motor when speed was turned to high. Recommend unit be cleaned as needed to prolong life expectancy of components.

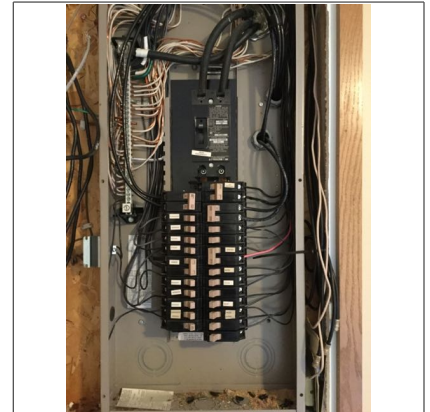
Observed ground and neutral conductor sharing the same lug. Neutral and ground conductors should not share the same lug.

Recommend consulting with a licensed electrician regarding proper grounding techniques.

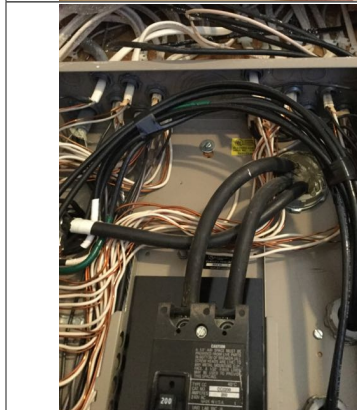
Observed multiple conductors sharing the same lug. Conductors should not share the same lug.

Recommend consulting with a licensed electrician regarding double tapping of conductors.

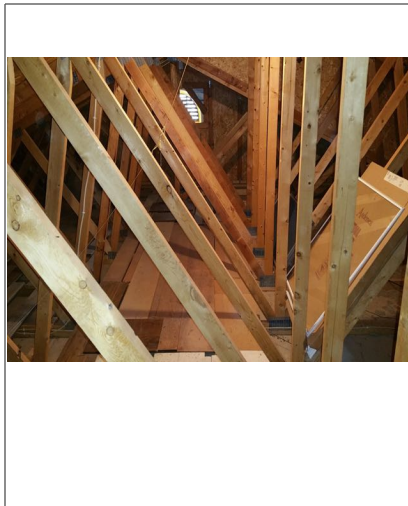
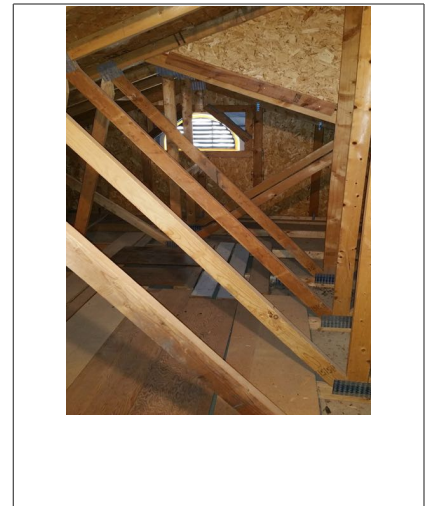
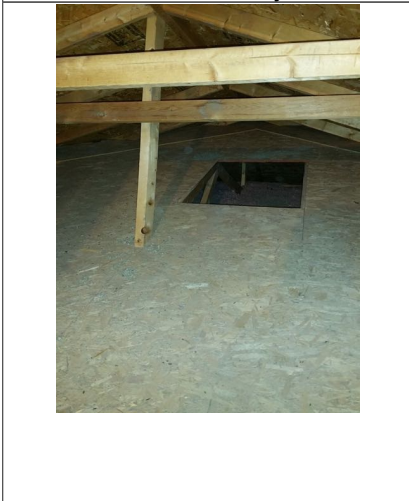
Observed unstable attic access ladder. Recommend upgrading access ladder for safety reasons.
