# *Property Condition Report*

High Point Shopping Center  
1234 Main Street  
Rochester, MN 55901

**Inspection Date:** 02/12/2016

Integri-Spec LLC  
479 Mankato Ave Suite 204  
Winona, MN 55987  
507-458-4566

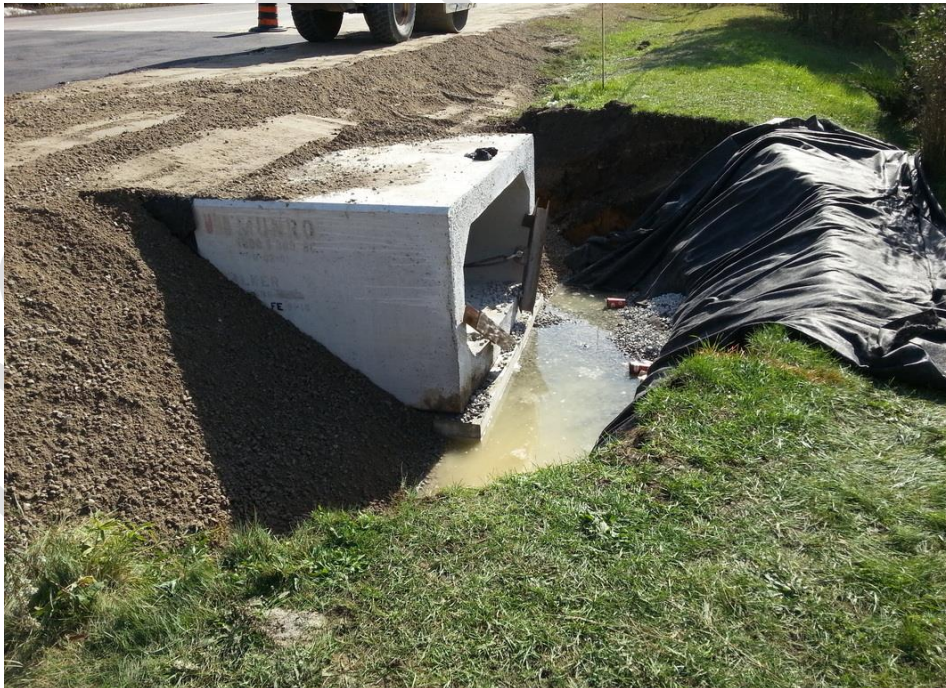
Detention pond with drainage culverts in the southern portion of the subject property

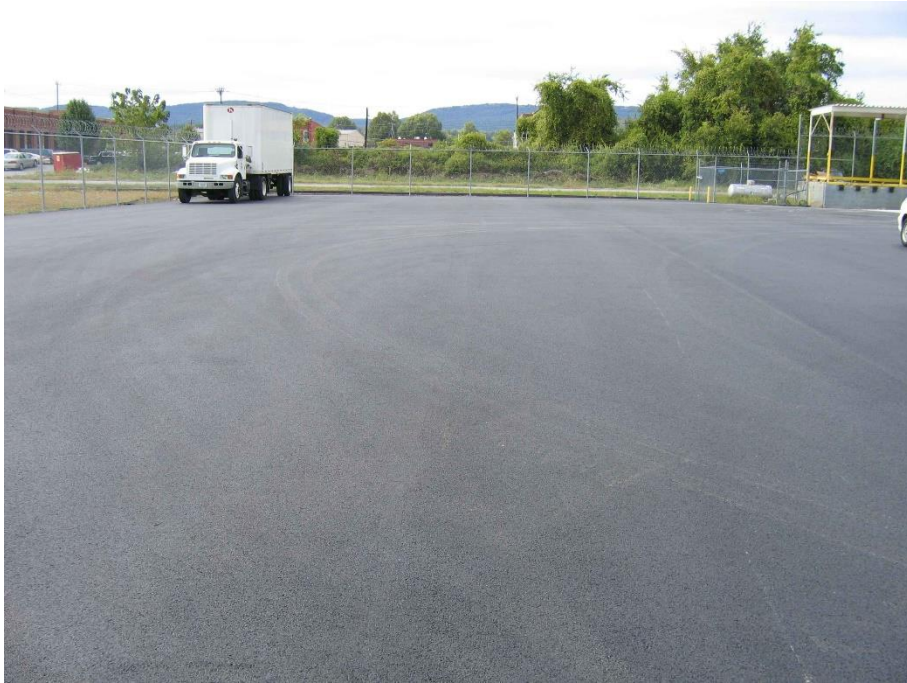
While the majority of the main parking lot and driveways have been sealed recently, it appears that many areas with pavement damage, such as alligator cracking, were sealed over, rather than repaired. Alligator cracking and raveling was observed in many locations. Additionally, the rear (north) service drive exhibits significant cracking and raveling. The damaged/deteriorated asphalt pavement should be repaired/replaced, in order to prevent further deterioration. Minor cracks can be crack filled, some areas can be patched/ overlain and the more significantly deteriorated areas should be removed and repaved. An opinion of costs for this work has been included in the Short Term Costs Table.

Recently overlain pavement

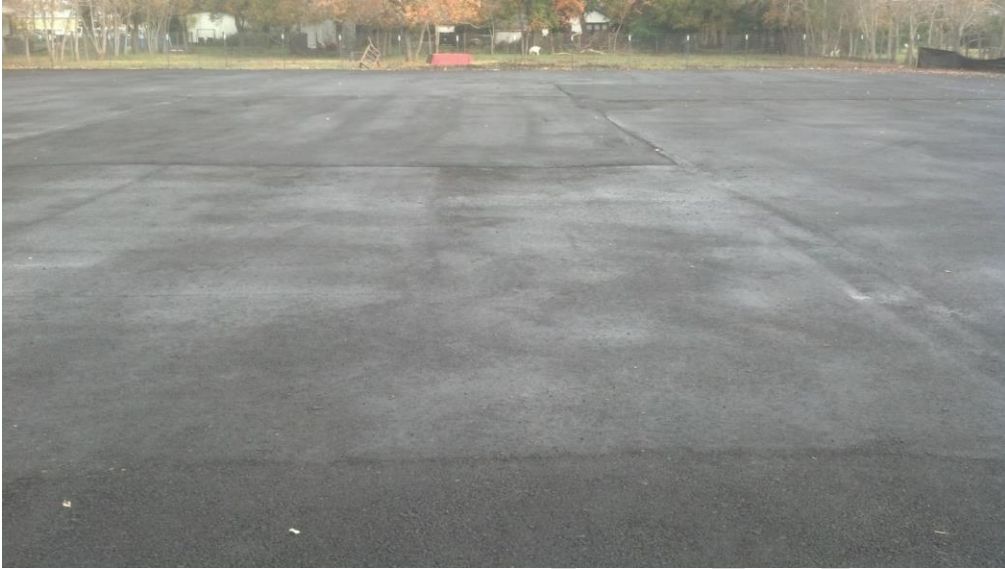
Typical pavement condition

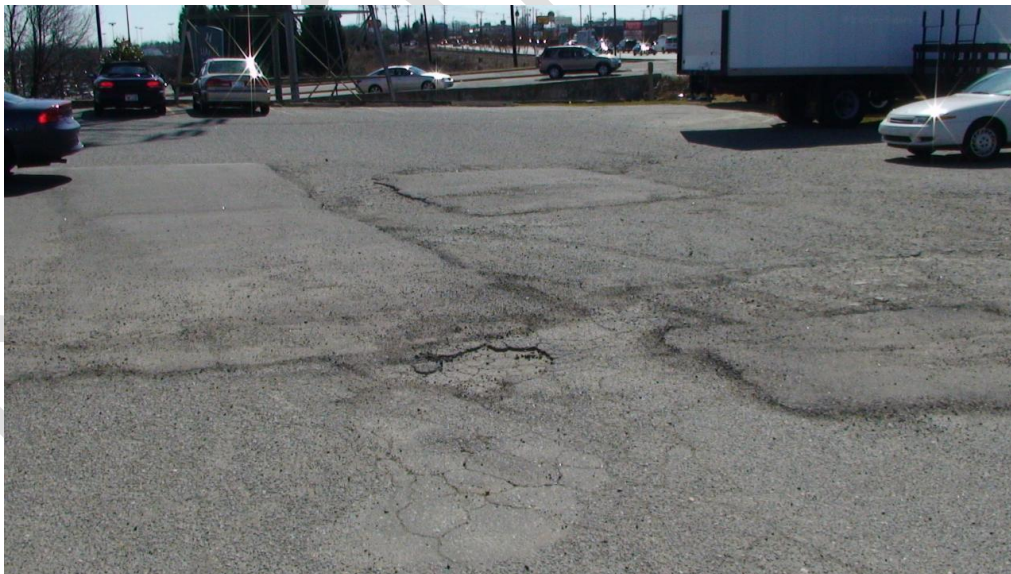
Recently overlain pavement

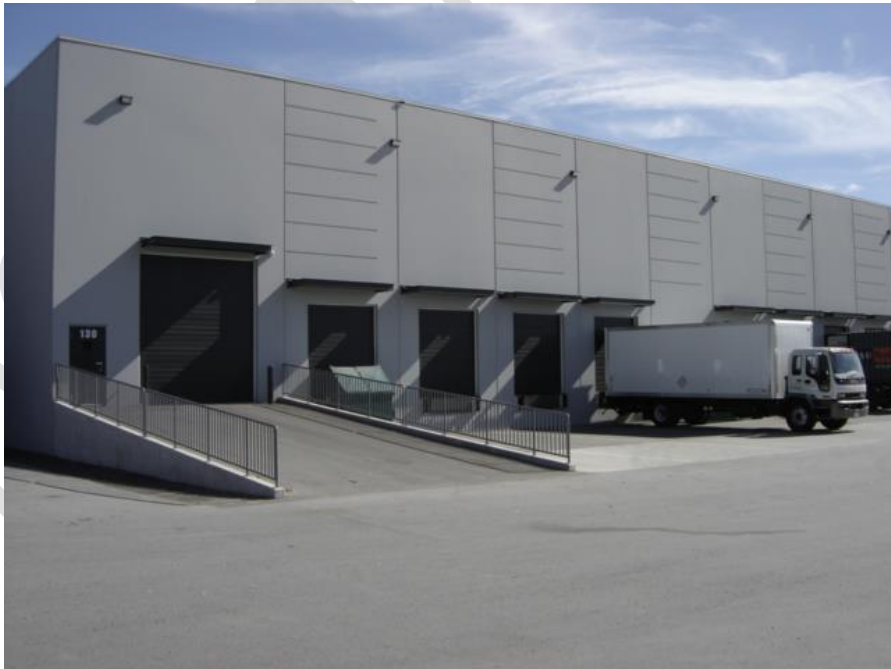
Concrete pad for loading dock

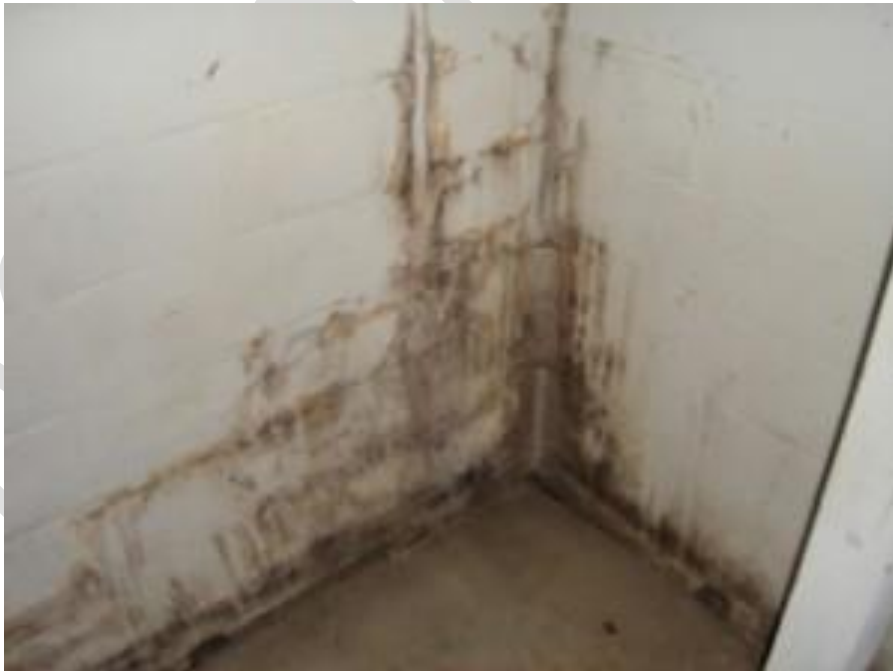
Cracking of the CMU walls throughout the rear building areas was observed, some of which is significant. Some of the cracking appears to have led to interior water intrusion issues.

Evidence of water intrusion

**Recommendations:** CMU walls showing damage on both the interior and exterior should be repaired, cleaned and maintained, and testing should be completed to positively determine the reason for the observed water intrusion. An opinion of costs for this work has been included in the Short Term Costs Table.

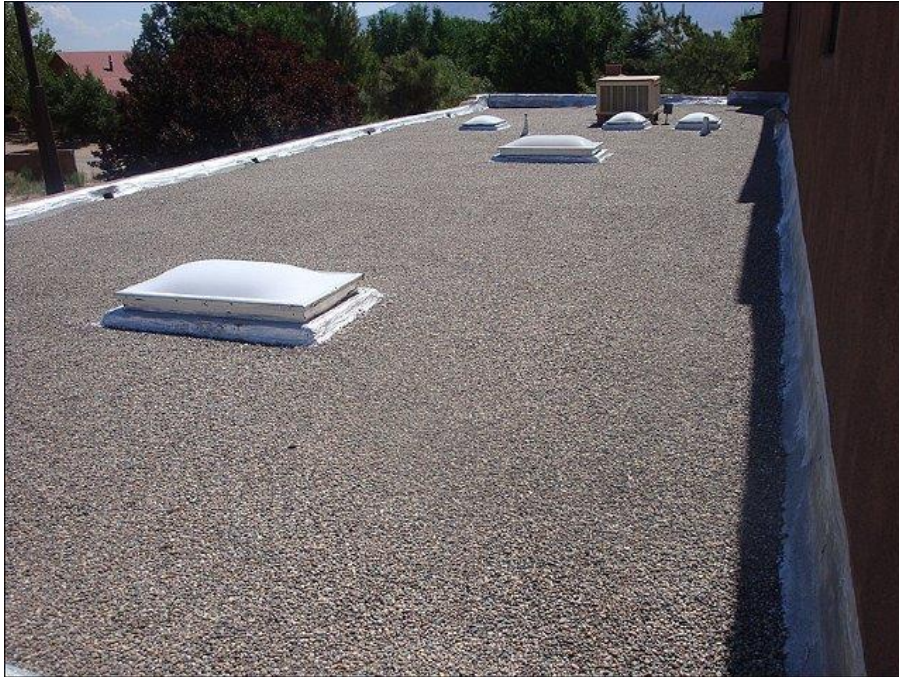
Based on the age of the roof, reported significant roof leaks, and a EUL of 20 years for flat roofs, replacement will likely be required at the beginning of the term. An opinion of costs for this work is included in the Short Term Costs Table.

Roof surface, note reflective sealant

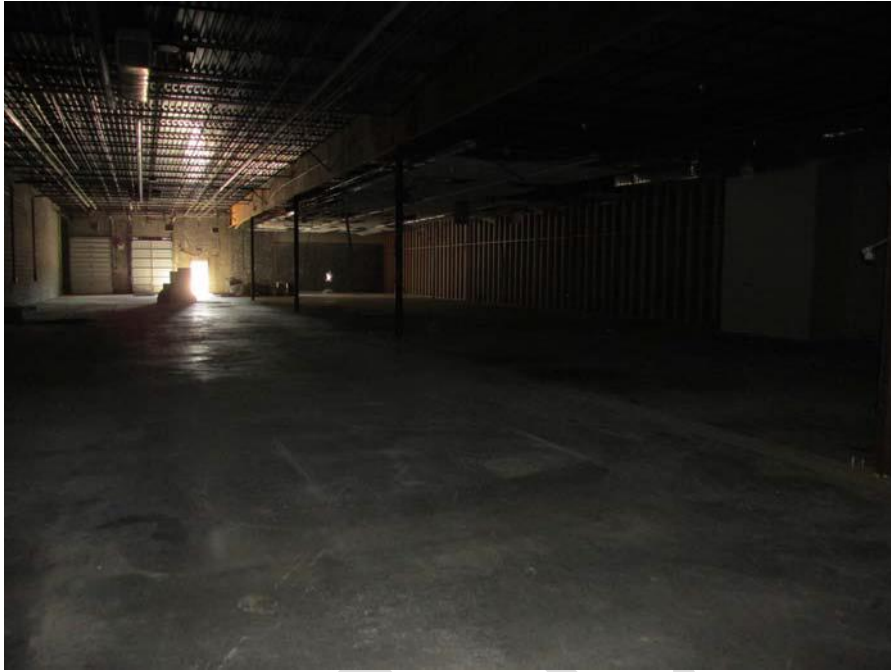
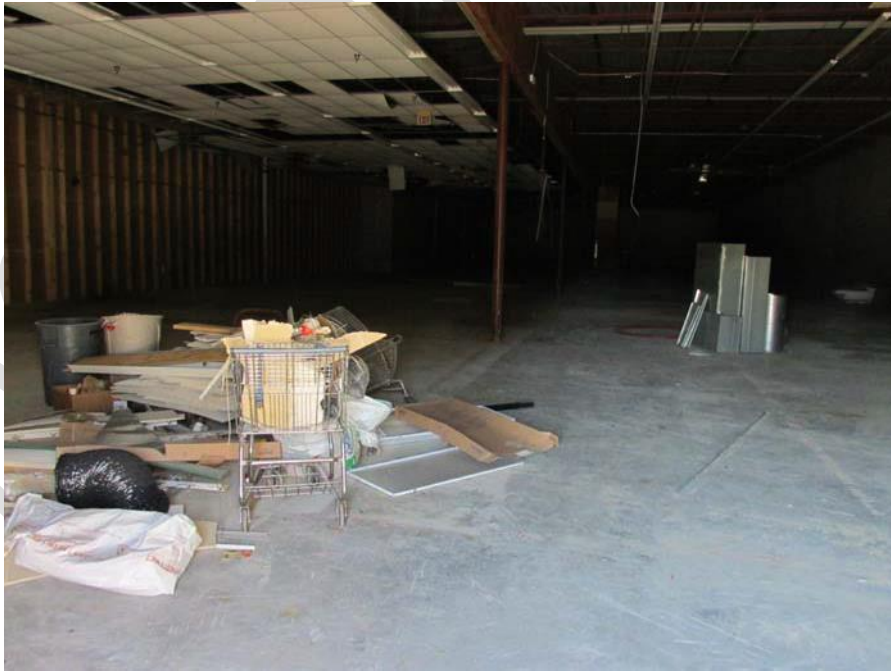
While one of the tenant spaces is vacant, no down areas due to damage or other serious concerns etc., were noted or reported. The vacant unit is mostly gutted with some finishes remaining. These areas would be addressed and built-out/renovated as part of TI allowances at the beginning of the lease; therefore, no costs to address these areas have been allocated.

Vacant tenant space

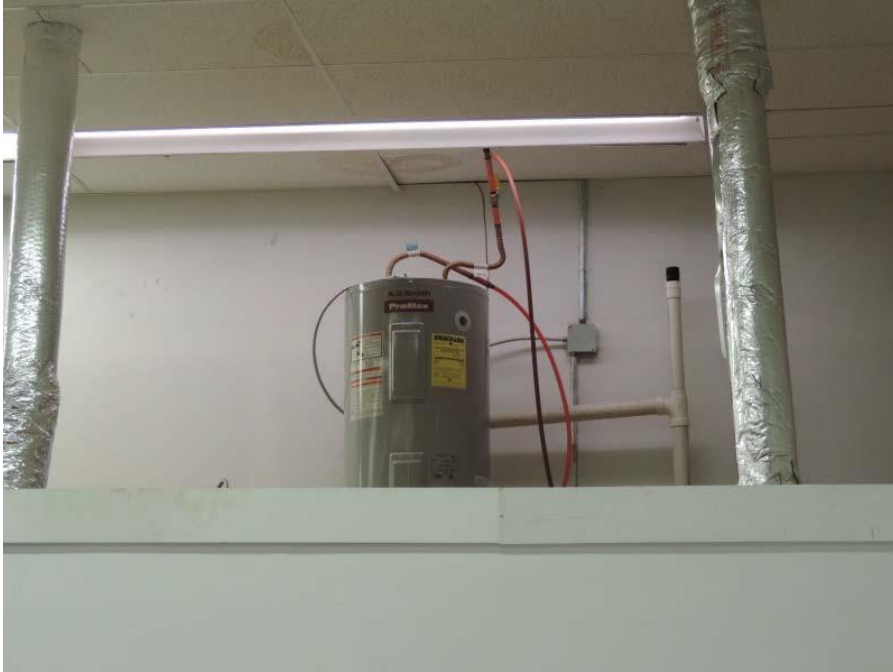
Tenant space water heater

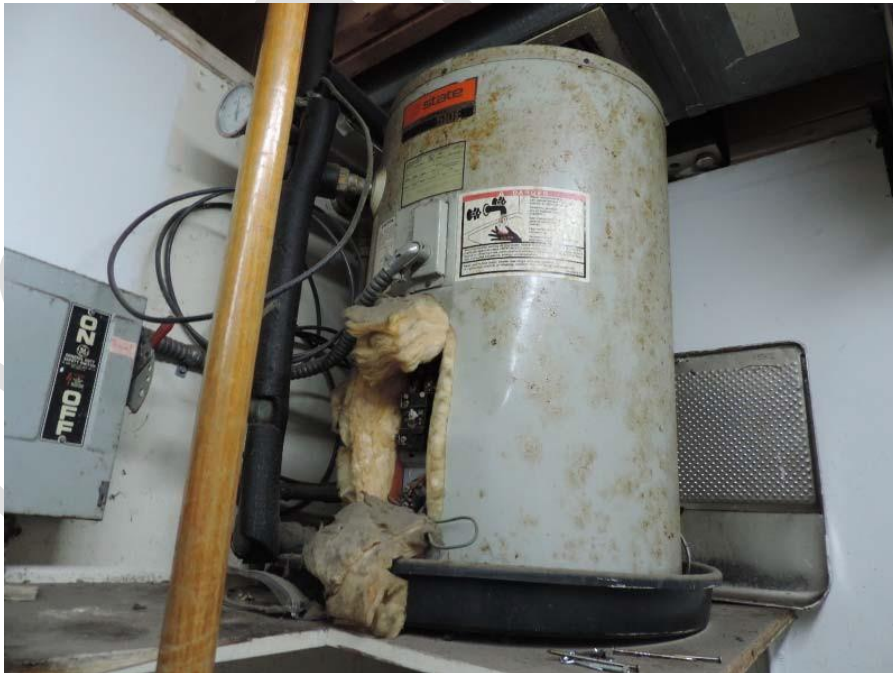
Tenant space water heater

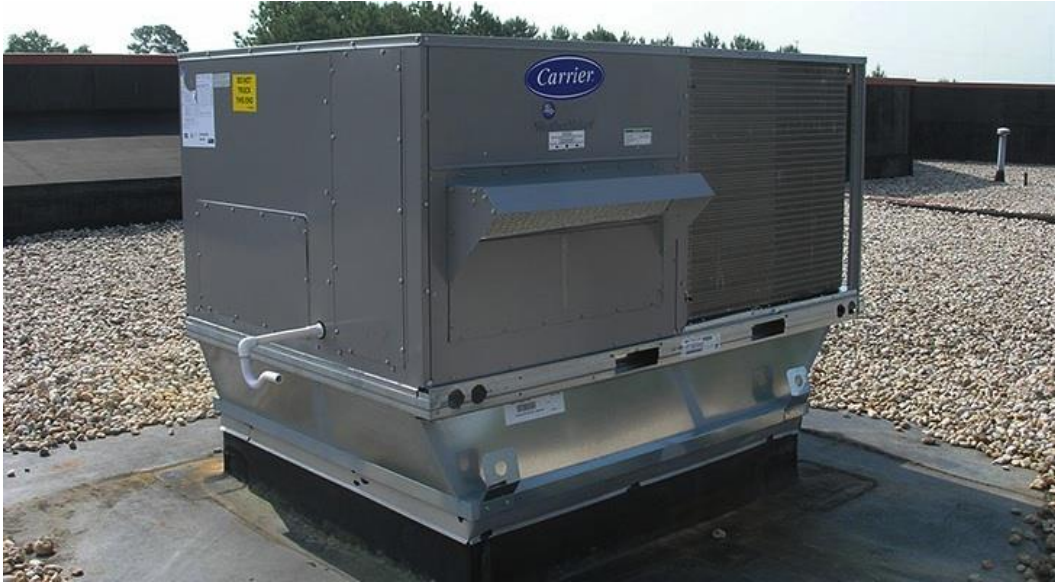
Rooftop packaged HVAC units

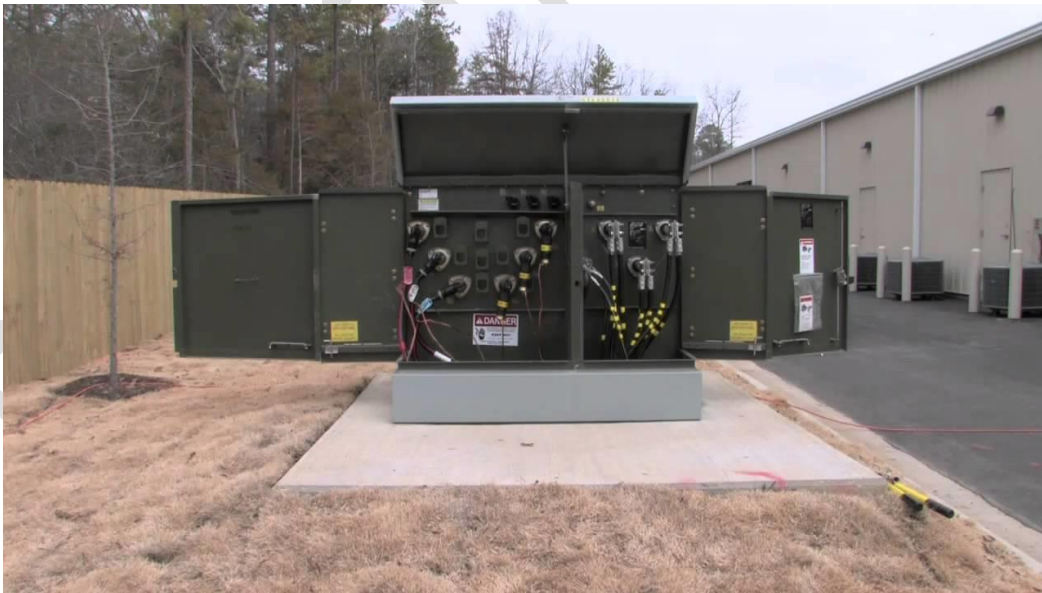
Utility electrical transformers

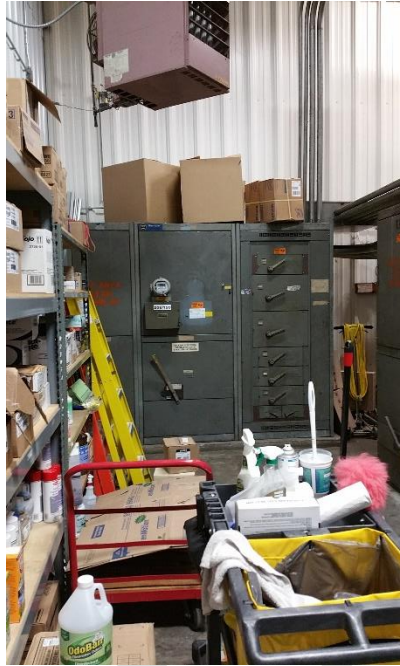
Electrical distribution panel and switchgear

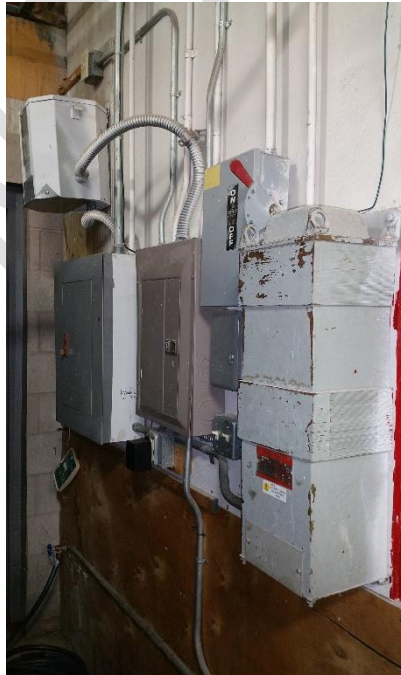
Typical electrical equipment in tenant space

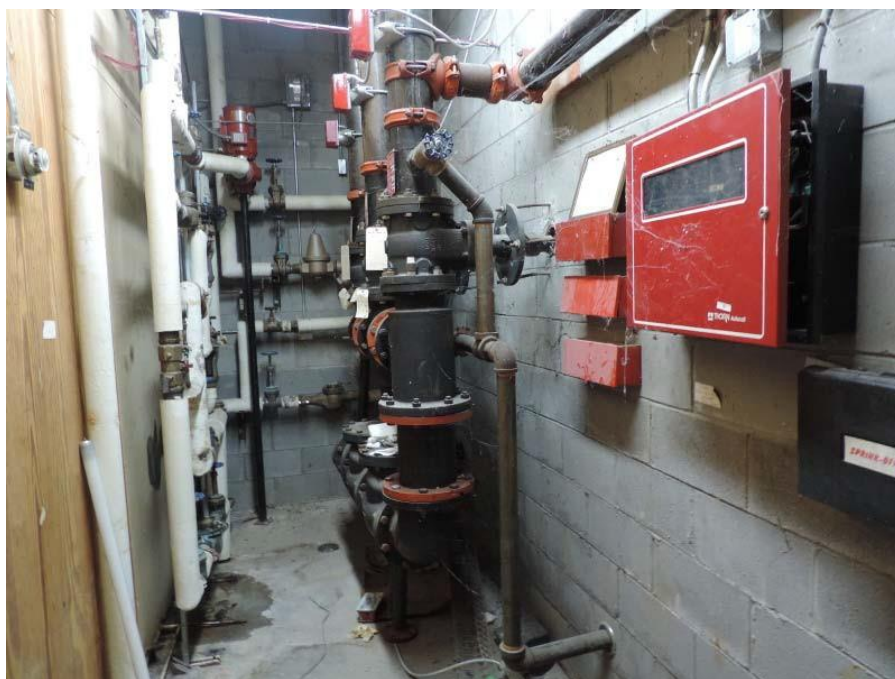
Sprinkler riser and alarm panel

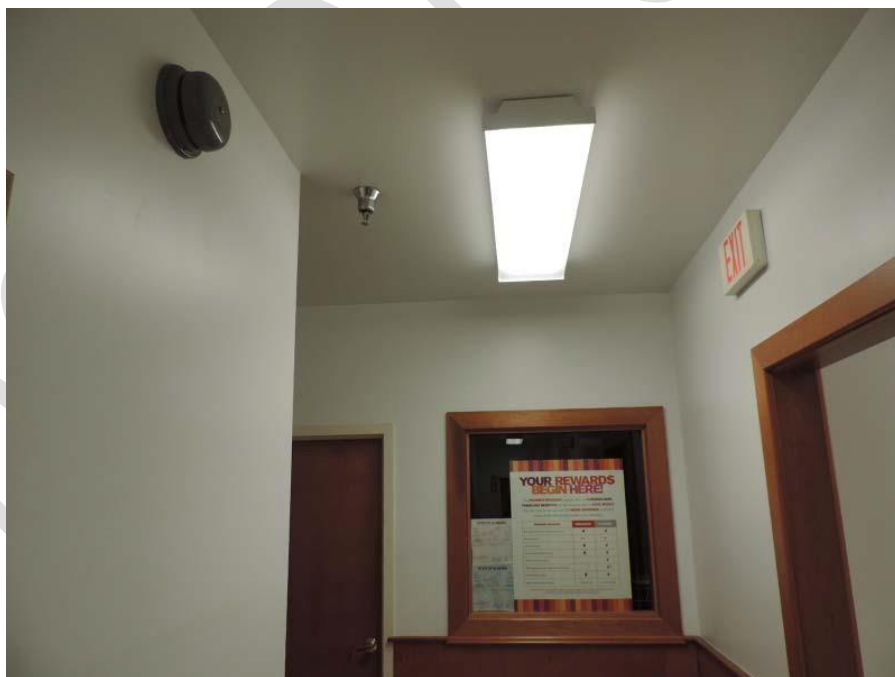
Interior alarm bell, sprinkler head and exit sign

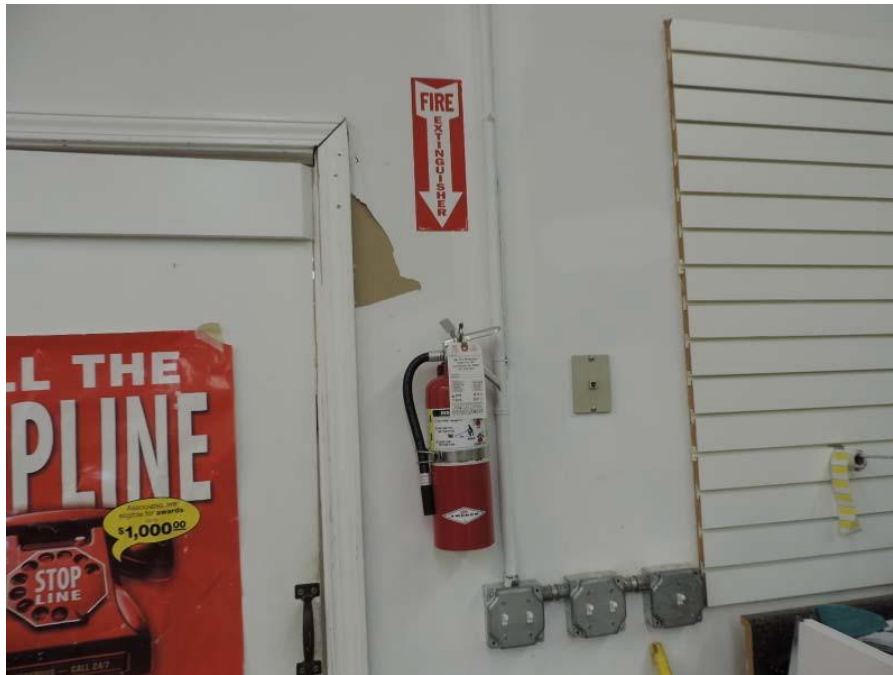
Fire extinguisher

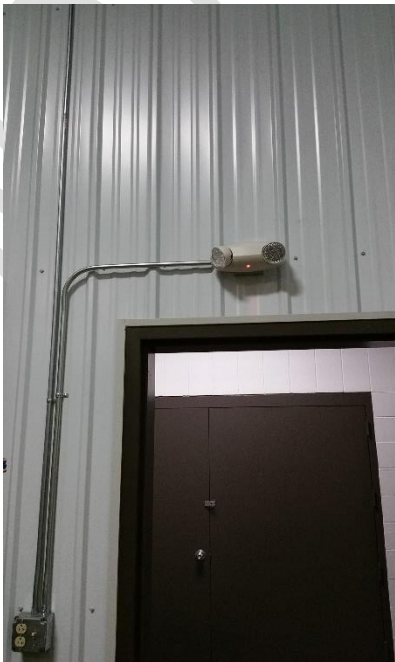
Emergency lighting and exit sign

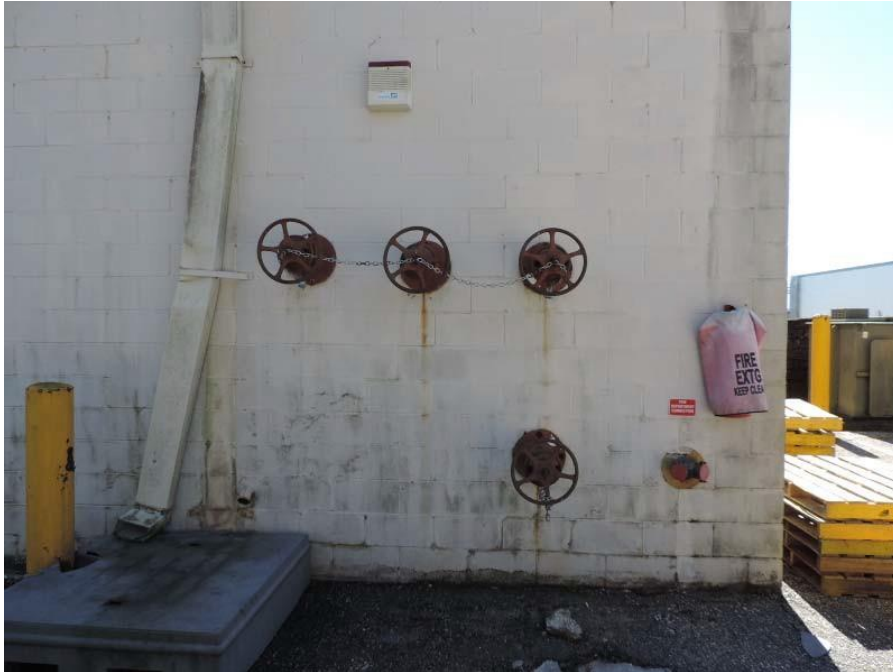
Fire department connection

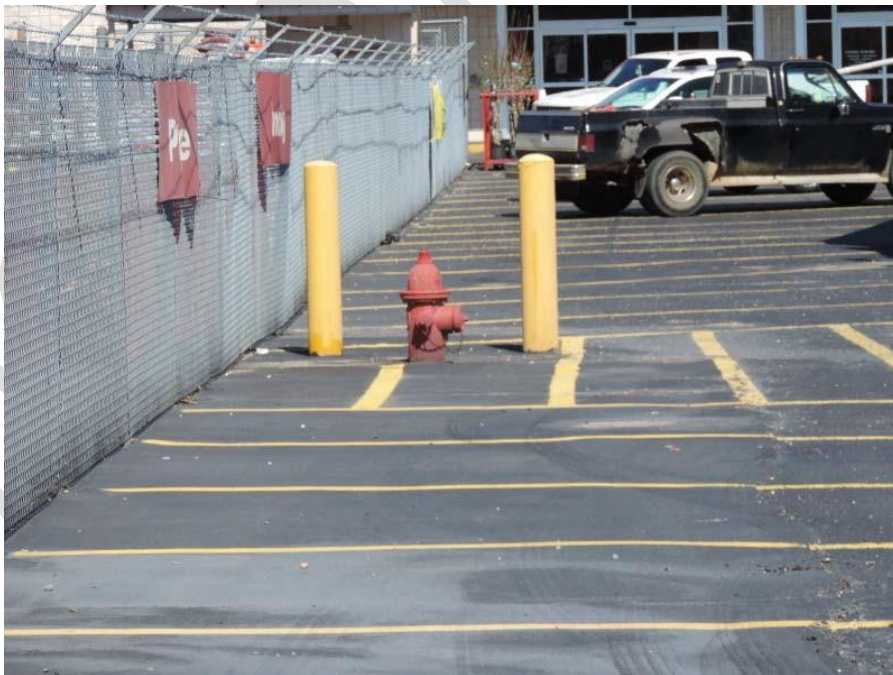
Fire hydrant

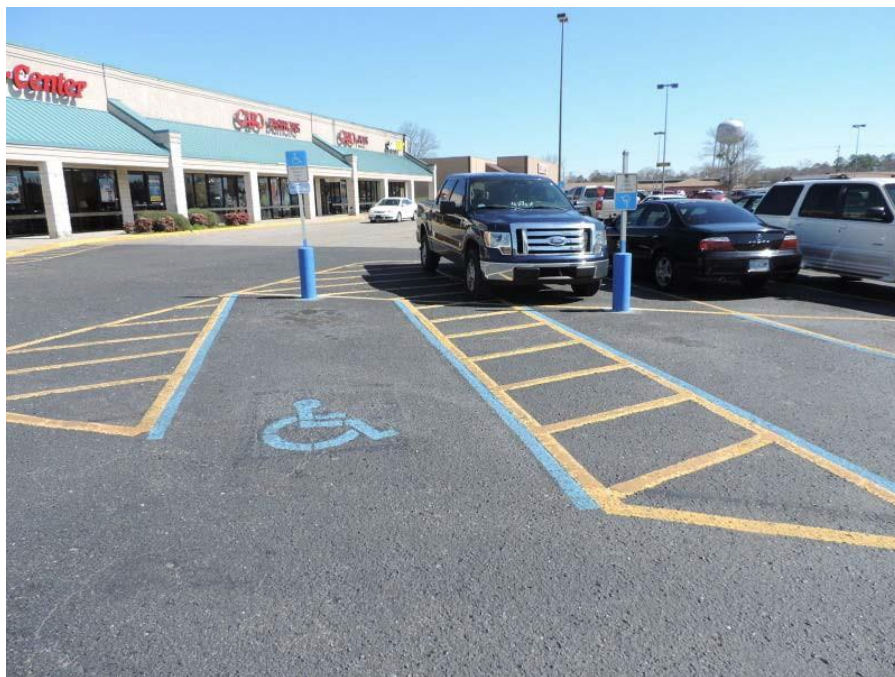
ADA parking spaces

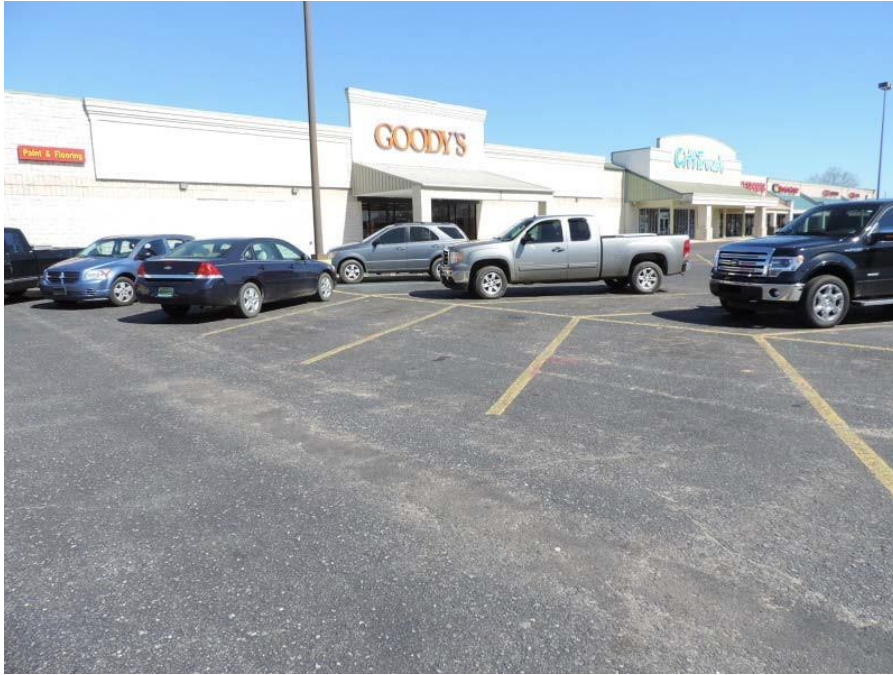
Property overview – Building and pavement

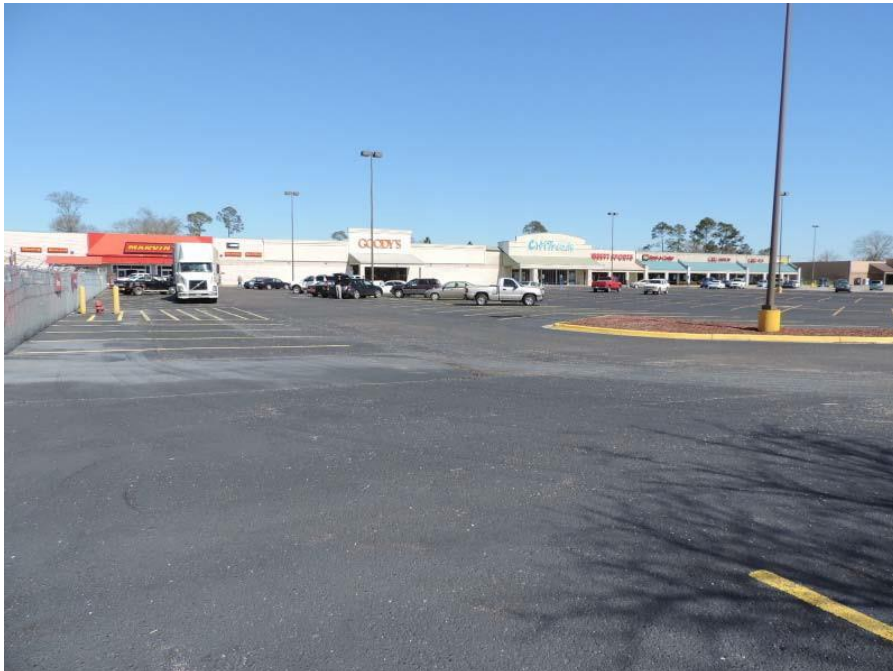
Property overview – Building and pavement

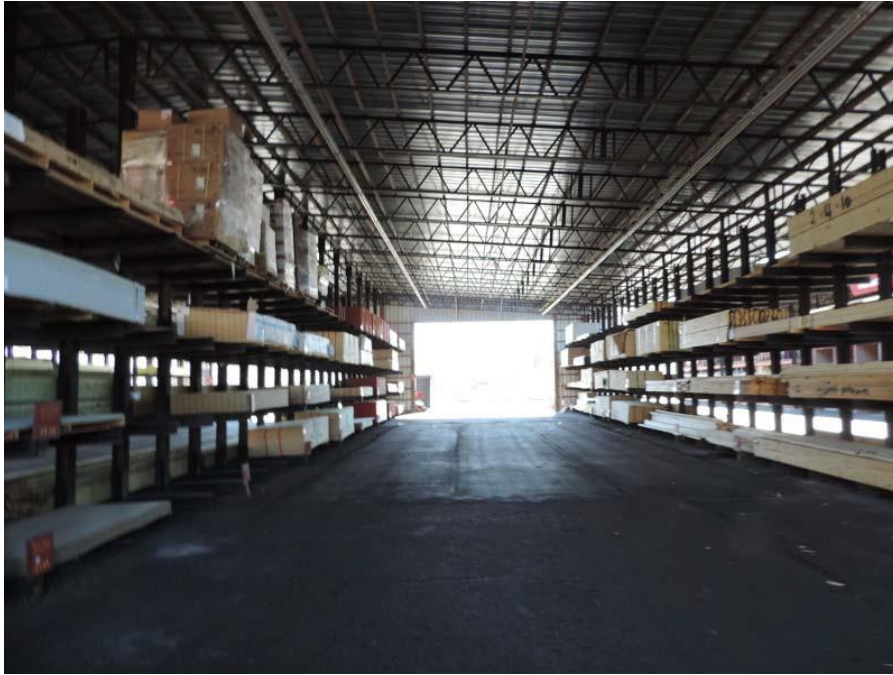
Property overview – Interior of lumber storage sheds

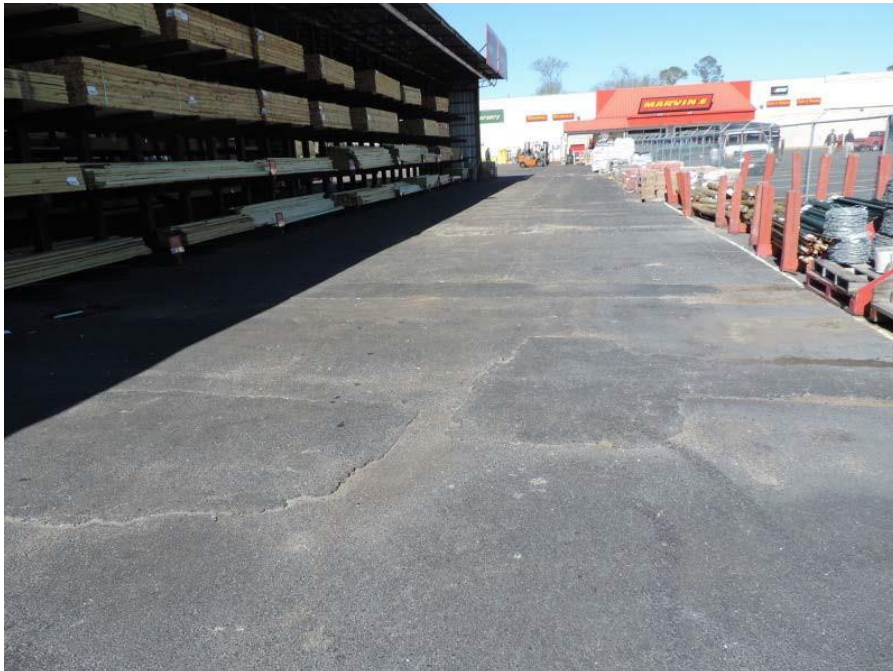
Property overview – Lumber storage area
