Home Inspection Report

51234 Main Street, Winona, MN 55987

Sunday, January 1, 2017

Integri-Spec Home Inspections

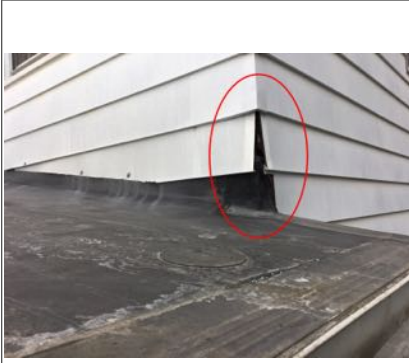
Observed gap in siding which may be a possible point of moisture intrusion.

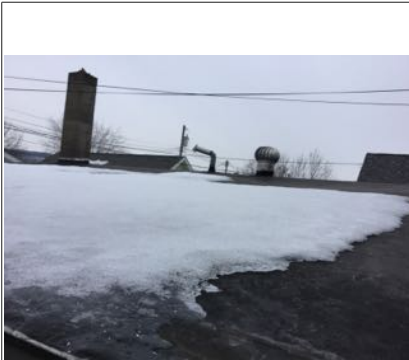
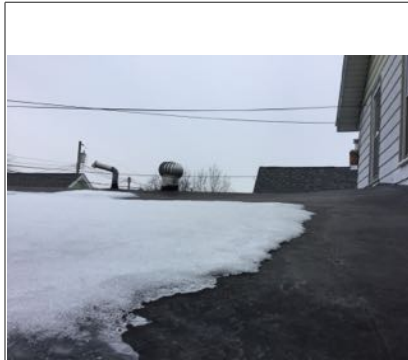
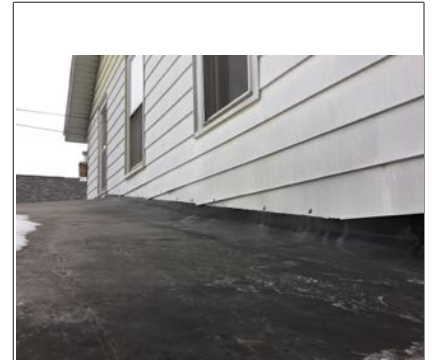
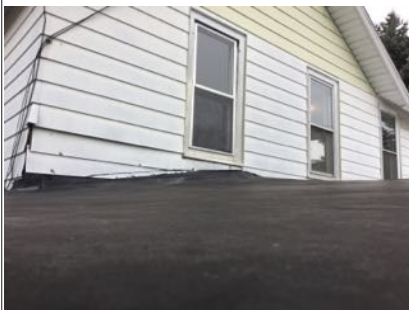
The roof was not inspected due to snow cover and as such the condition of the roof coverings could not be evaluated.

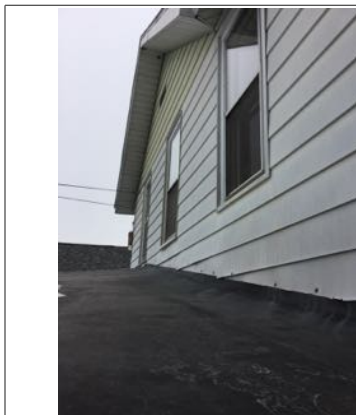
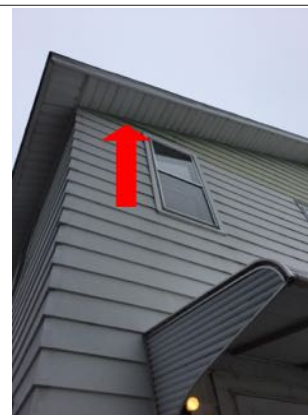
Observed loose siding.

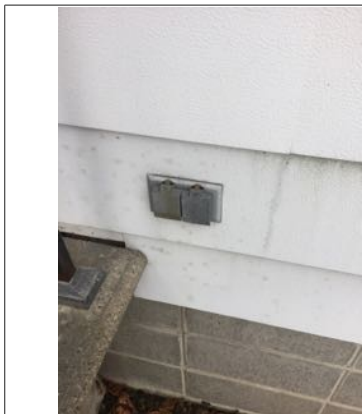
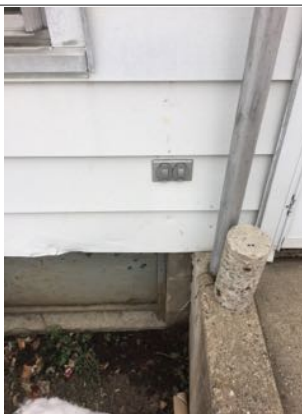
Receptacle on back of home exterior did not work.
 Recommend licensed electrician review and repair as necessary.

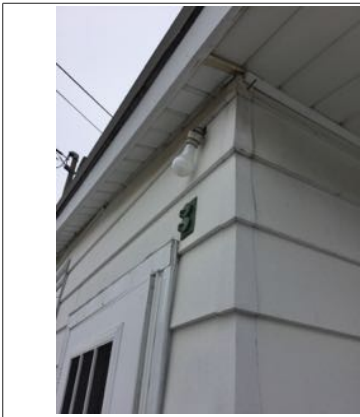
Observed exterior light Not installed correctly. Recommend licensed electrician review and repair as necessary.

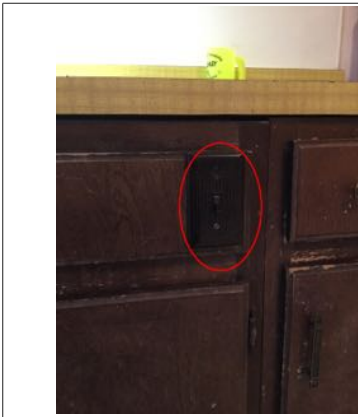
Observed switch mounted at front of kitchen counter near sink. Unsure of what it operates. Recommend asking seller prior to closing.

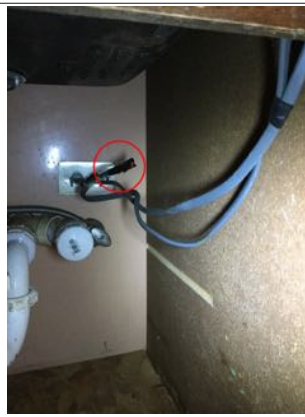
Observed spliced electrical wire not enclosed in junction box. Recommend licensed electrician review and repair as necessary.

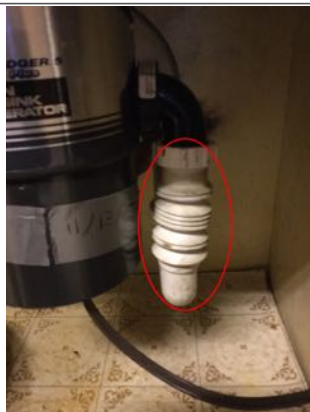
As a performance upgrade, Recommend use of a rigid pvc fitting to maximize flow of drain water.

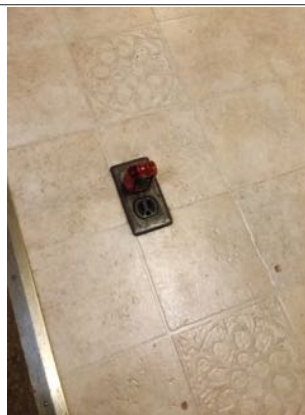
In floor mounted receptacle did not appear to be turned on.
 Recommend floor mounted receptacles be GFCI protected.

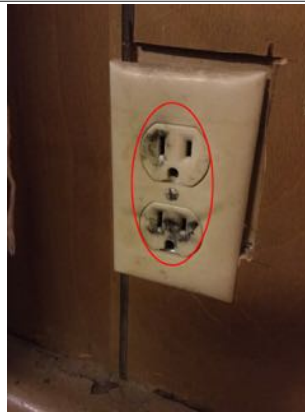
Observed signs of electrical burns. Recommend licensed electrician review.

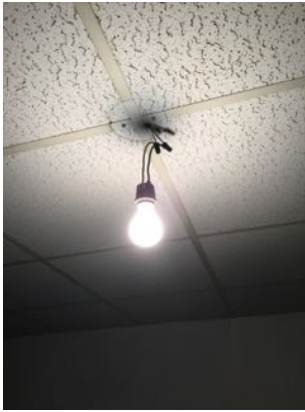
Observed ceiling mounted light not enclosed in appropriate enclosure. Recommend licensed electrician review and repair as necessary.

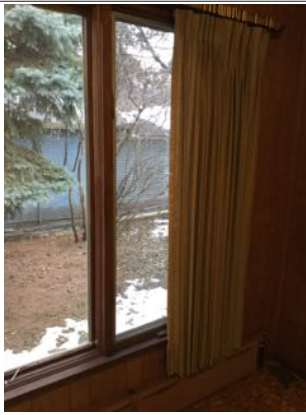
Unable to operate window on right side due to broken crank hardware.

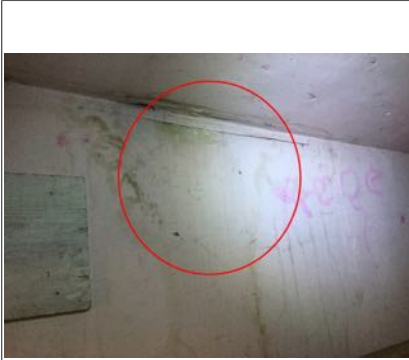
Observed what appears to be water stain and possible microbial growth. Recommend monitoring location for signs of active water intrusion.

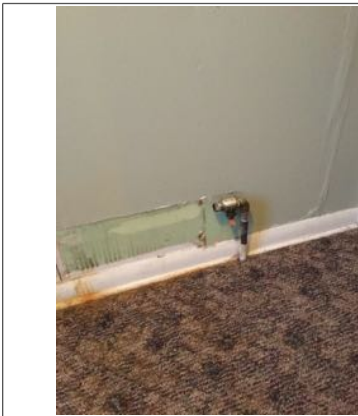
Observed unknown supply lines.
 Unsure of operation or what
 liquid/gas may be supplied.
 Recommend asking sellers prior
 to closing.

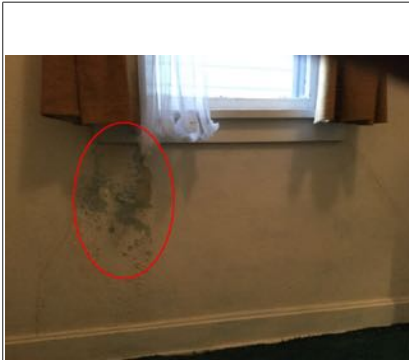
Observed what appears to be water stain.

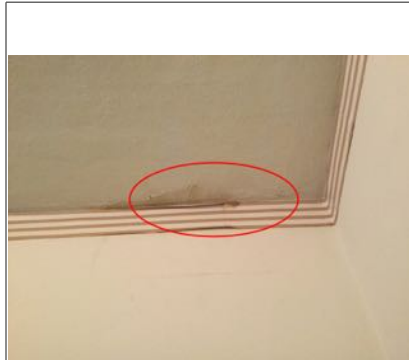
Observed what appears to be water stain.

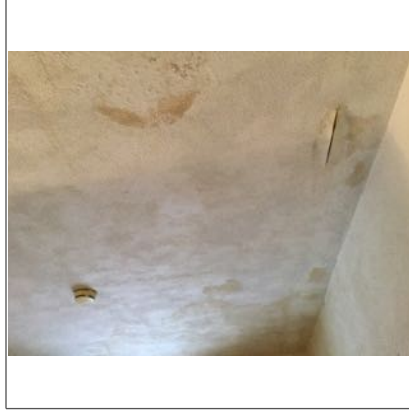
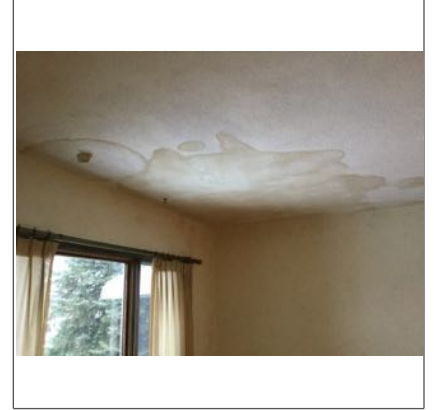
Location First floor

Walls & Ceiling ☐ Satisfactory ☐ Marginal ☒ **Poor** ☐ Typical cracks ☒ Damage

Moisture stains ☒ Yes ☐ No

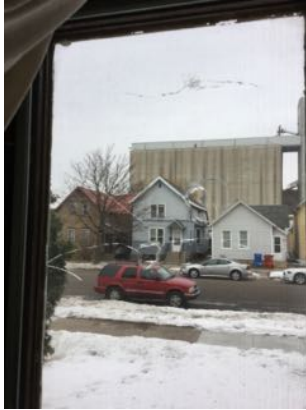
Observed broken glass

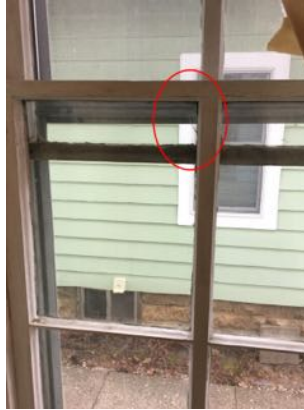
Observed cracked glass

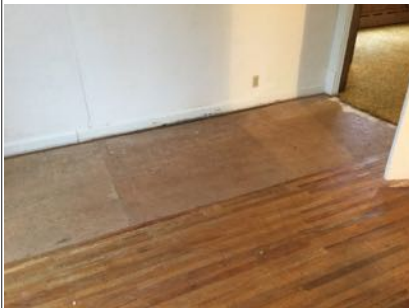
Observed what appears to be removed carpet likely due to water damage to ceiling.

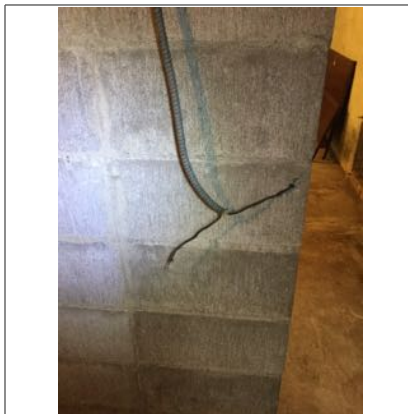
Observed exposed electrical wire not in junction box. Recommend licensed electrician review and repair as necessary.

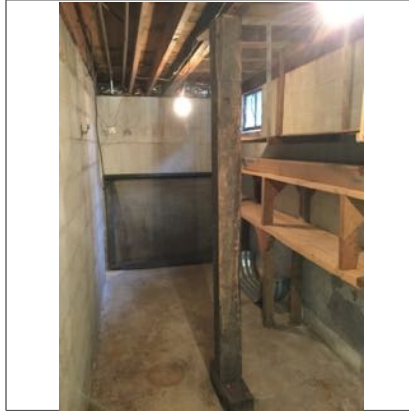
Comments Wood column does not appear to be adequate for structure - recommend further evaluation by a qualified contractor or a licensed structural engineer.

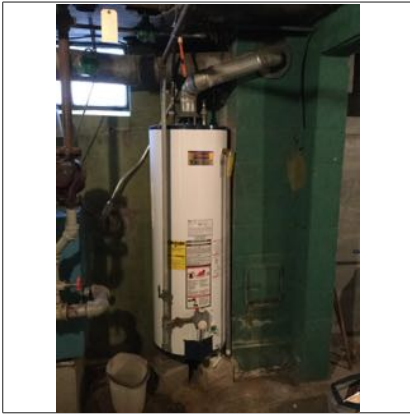
Comments Water heater nearing its life expectancy recommend budgeting for new unit.

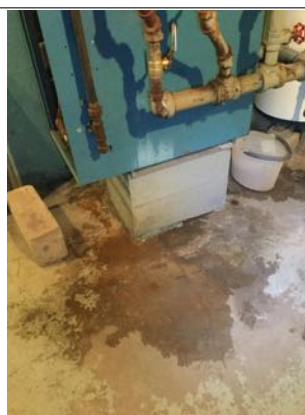
Observed water leak near boiler.
Recommend licensed
professional review and repair as
needed to ensure leak is
eliminated.

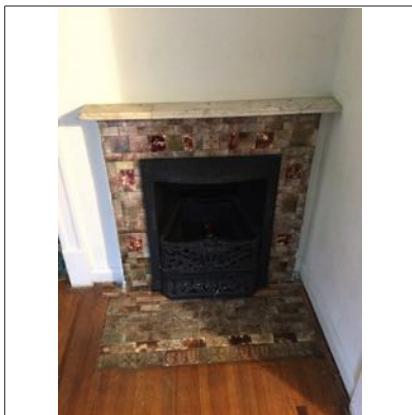
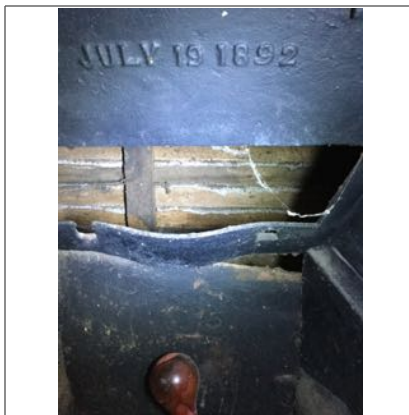
☐ Satisfactory ☐ Marginal ☒ Poor ☐ Recommend having flue cleaned and re-examined
☐ Not evaluated

Recommend professional review and provide scope of work needed in order to bring fireplace to an operable condition. Do not use until professional has evaluated and signed off in safety of use.

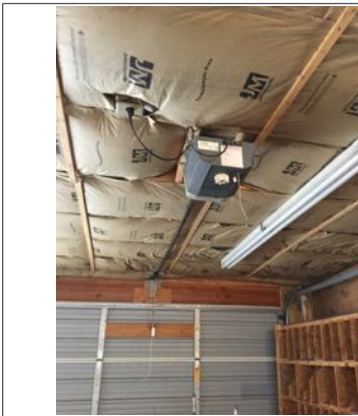
Door marked West operates but does not respond to wall button nor does the trolley engage with door.

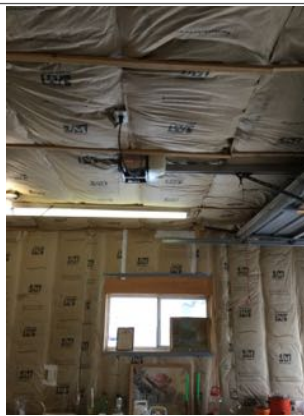
Door marked East operates and responds to wall button.

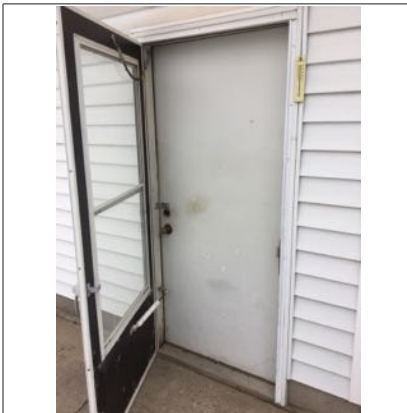
☐ None ☒ Present
Condition ☐ Satisfactory ☐ Marginal ☐ Poor ☐ Damaged/Rusted
Comments Door was locked and therefore operation and condition of door was not tested and excluded from scope of inspection. Recommend reviewing operation of door prior to closing.

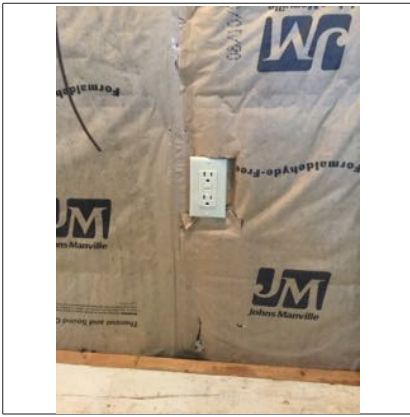
Electrical Receptacles

☒ Yes ☐ No ☐ Not Visible Operable: ☒ Yes ☐ No
Reverse polarity ☐ Yes ☒ No
Open ground ☐ Yes ☒ No ☐ Safety Hazard
GFCI Present ☒ Yes ☐ No Operable: ☒ Yes ☐ No ☐ Handyman/extension cord wiring
☐ Recommend GFCI Receptacles
